**Redegørelse i anledning  
af tre havarier  
med Dash8 Q400**

**Bilag til redegørelsens kap. 6**

**Hæfte 1**

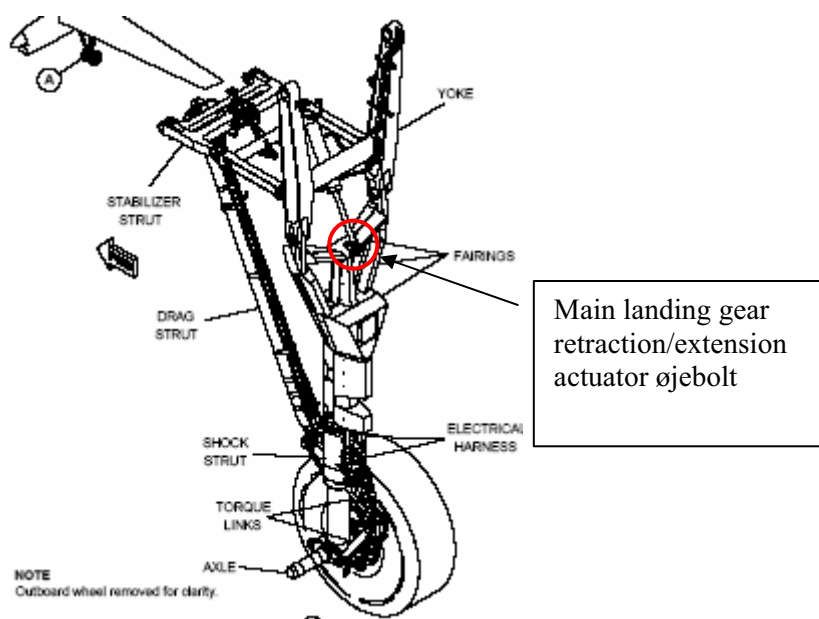
De tekniske undersøgelser har været koncentreret om det højre landingsstel. En skitsefigur heraf er vist nedenfor.

Under undersøgelserne blev det afdækket, at landingsstelsaktuatorens øjebolt var separeret fra aktuatorens stempel.

En undersøgelse af aktuatorstemplets indre gevind blotlagde tilstedeværelsen af korrosion, som har svækket materialet og ledte til separationen af øjebolten fra aktuatorstemplet. Denne separation var hovedfaktoren ledende til understellets kollaps.
