# Limfjord tunnel Assessment and retrofitting

Technical Summary Report, Version 1.0

Date 25. juni 2019

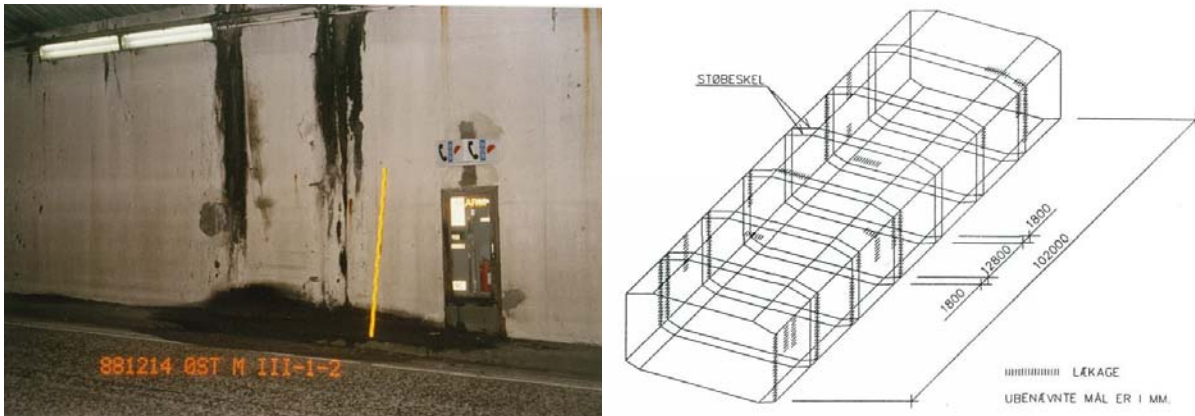
The leakages occurred mainly in or around the 1,8 m wide openings cast after the 12,8 m wide main sections. They were also concentrated in the top slab sections of elements II, III and IV.

Figure 4.4-1 Water Leakage at the short sections (Dimensions are shown in mm)

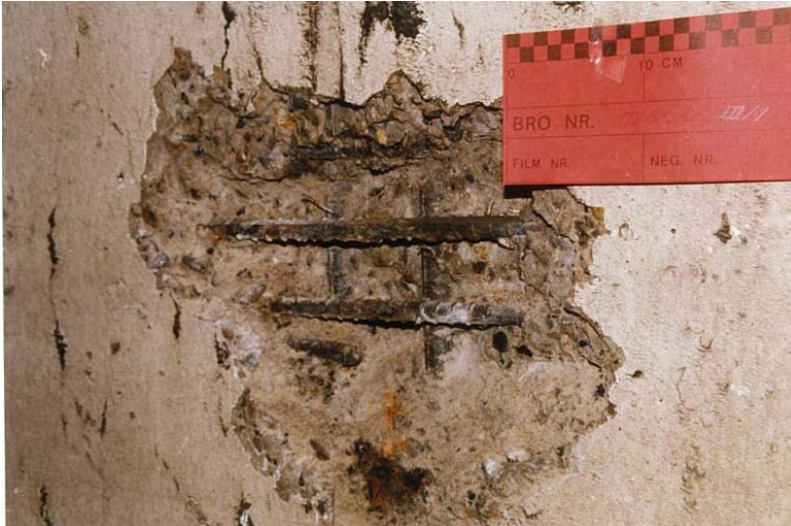
**Figure 4.5-1 Reinforcement corrosion from inspection in 1988.**

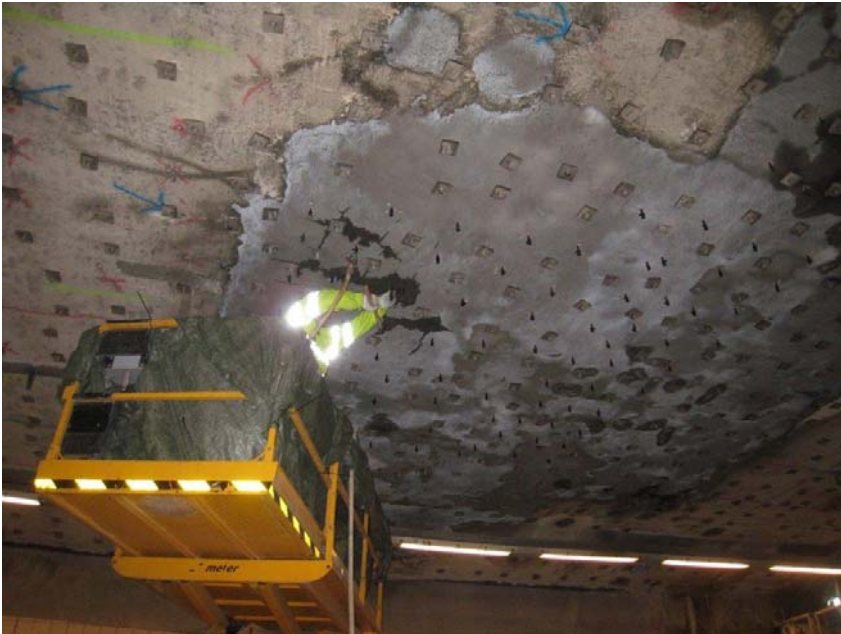
Figure 4.5-4 Injection of leaking cracks

Crack injection campaigns are therefore executed every winter on almost regular basis. The crack injections are possible during late evenings and nights when one tunnel tube can be closed for traffic without creating serious restrictions for the traffic. The impact on the flow of traffic is minimal as the tunnel can be kept completely open during daytime and rush hours.

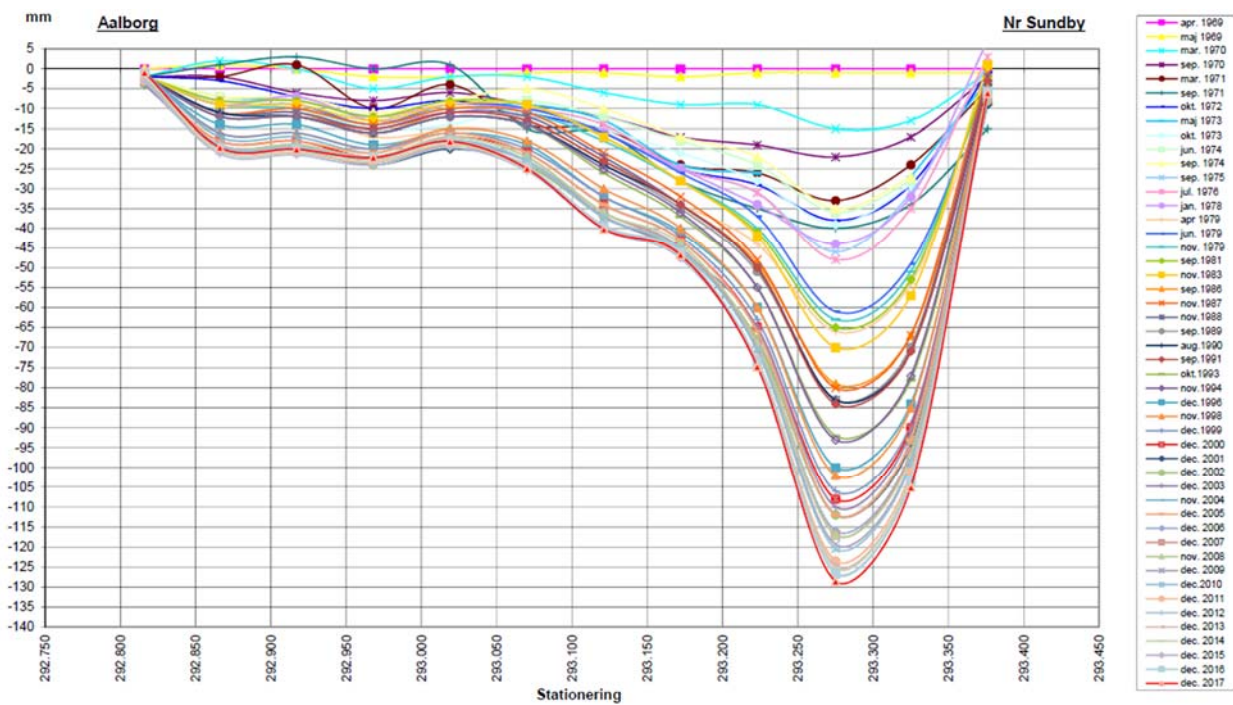
Additionally, continued settlements of the tunnel have been observed since 1969, in the northern section of the immersed tunnel reaching as much as 130 mm, which can be considered as substantial (Section 4.6). This has given another reason for concern for the Danish Road Directorate.

Figure 4.6-1 Recorded settlements during the period 1969 – 2017.

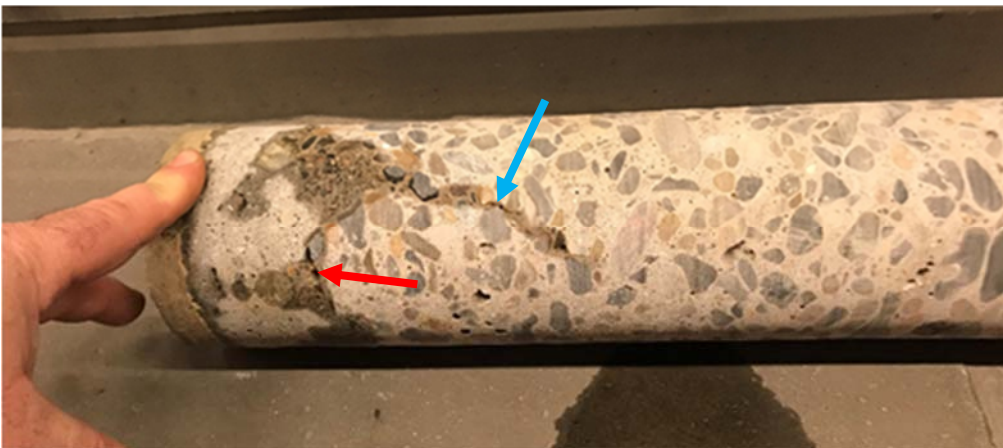
- The quality of the interface between the repair and the original concrete in the roof is assessed to be adequate to effectively transfer the shear forces although delamination is seen in some areas.

Figure 6.3-2 Core extracted from roof. The concrete is cracked both at the interface between repair and original concrete (red arrow) as well as within the original concrete (blue arrow).

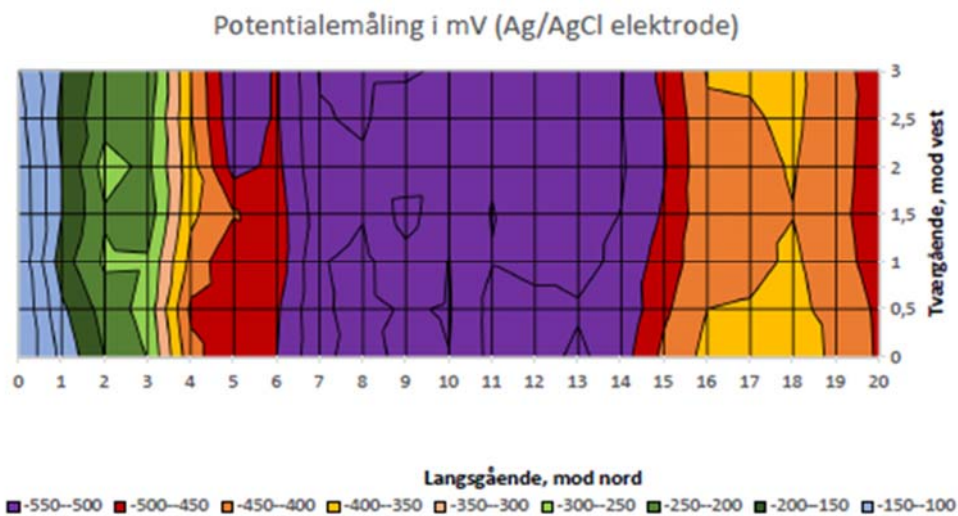
Figure 6.3-3 HCP results from roof. The whole area was wet. No corrosion observed on reinforcement in break out despite the very low potential (-600 mV). Investigated area at transition between element II (left - 3 m) and element III (right - 17 m).

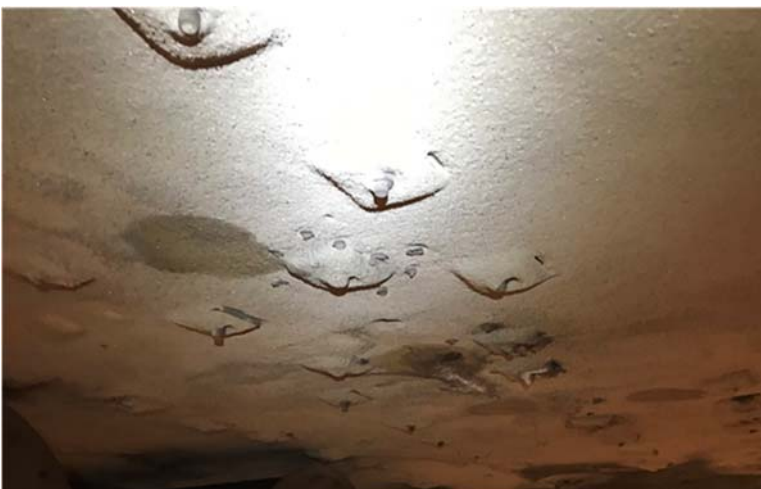
Figure 6.3-4 Area where fire protection has deteriorated.

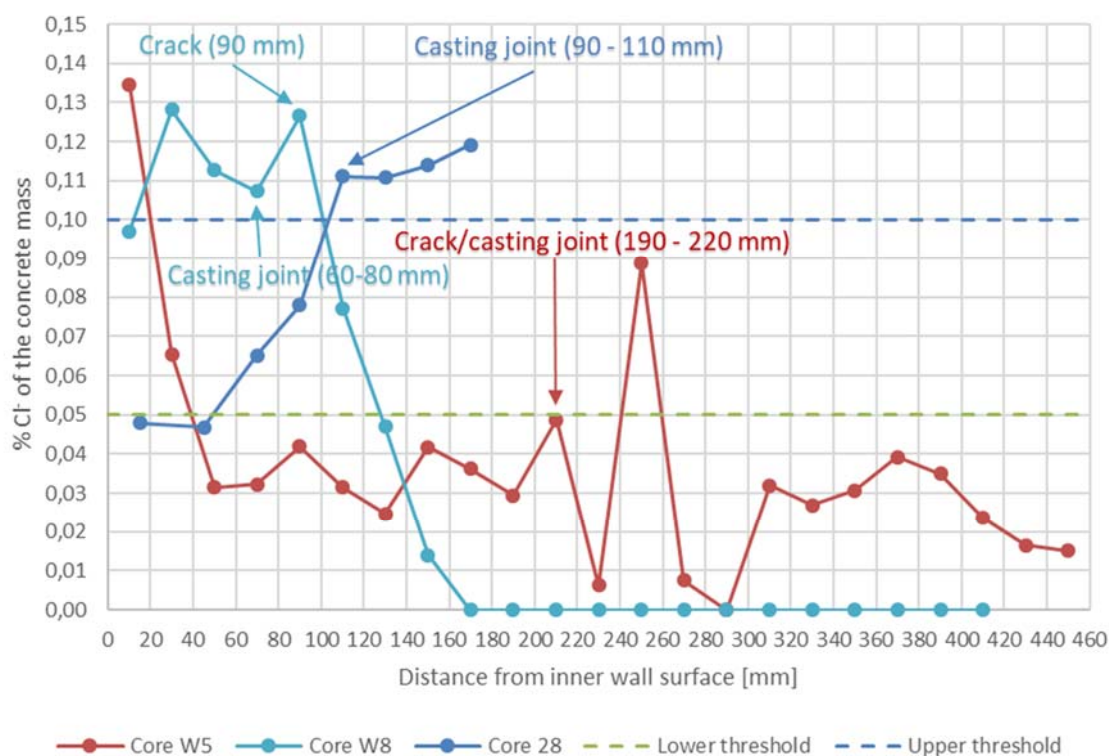
Figure 6.4-1 Chloride profiles from three cores taken from the inside of the eastern wall.

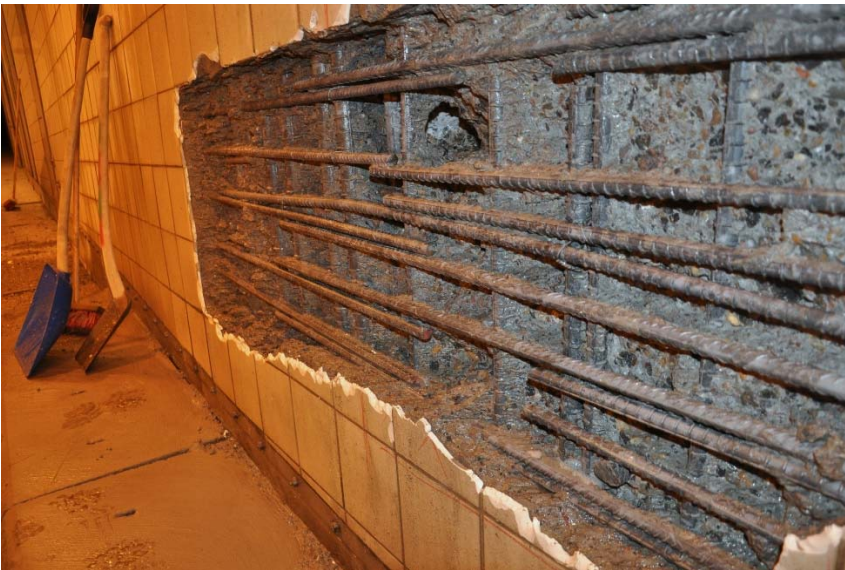
[Figure 6.7-3](#) Exposed reinforcement at the closure joint (Type 2 joint). No signs of butt-welded connections in the horizontal reinforcement.

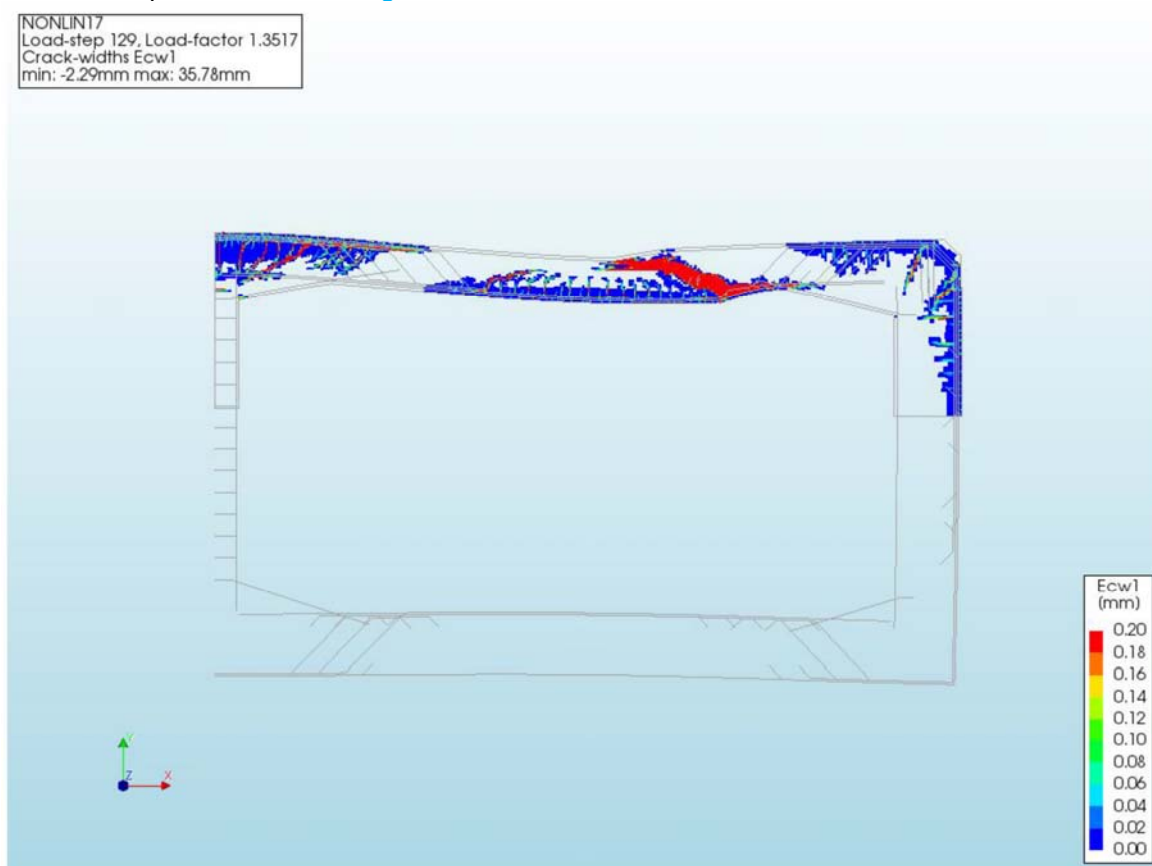
Figure 7.5-7 Base case. Crack patterns at max load level

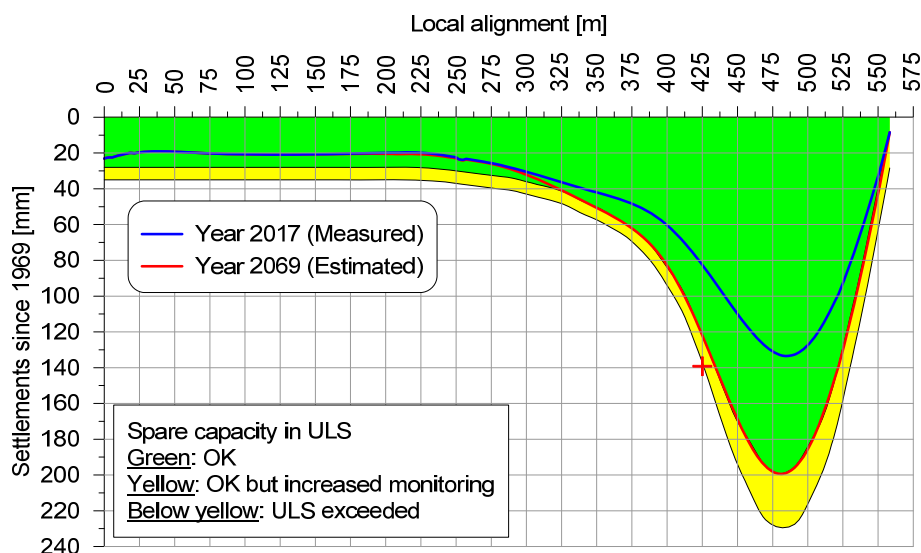
**Figure 8.5-1 Settlements of tunnel structure since 1969. Colour-code relates to whether the tunnel structure complies with existing regulations considering the ULS capacity.**
