**Foreløbig redegørelse
i anledning af havarier
med Dash-8 Q400
9. og 12. september 2007**

Bilag til redegørelsens kap. 6

**Aircraft Accident Notification Report
SK1209/09SEP2007**

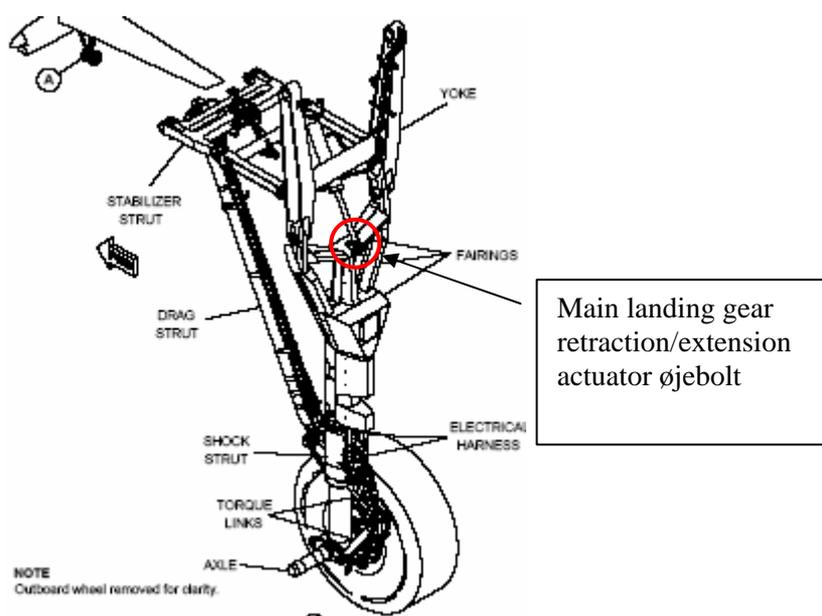
De tekniske undersøgelser har været koncentreret om det højre landingsstel. En skitsefigur heraf er vist nedenfor.

Under undersøgelserne blev det afdækket, at landingsstelsaktuatorens øjebolt var separeret fra aktuatorens stempel.

En undersøgelse af aktuatorstemplets indre gevind blotlagde tilstedeværelsen af korrosion, som har svækket materialet og ledte til separationen af øjebolten fra aktuatorstemplet. Denne separation var hovedfaktoren ledende til understellets kollaps.

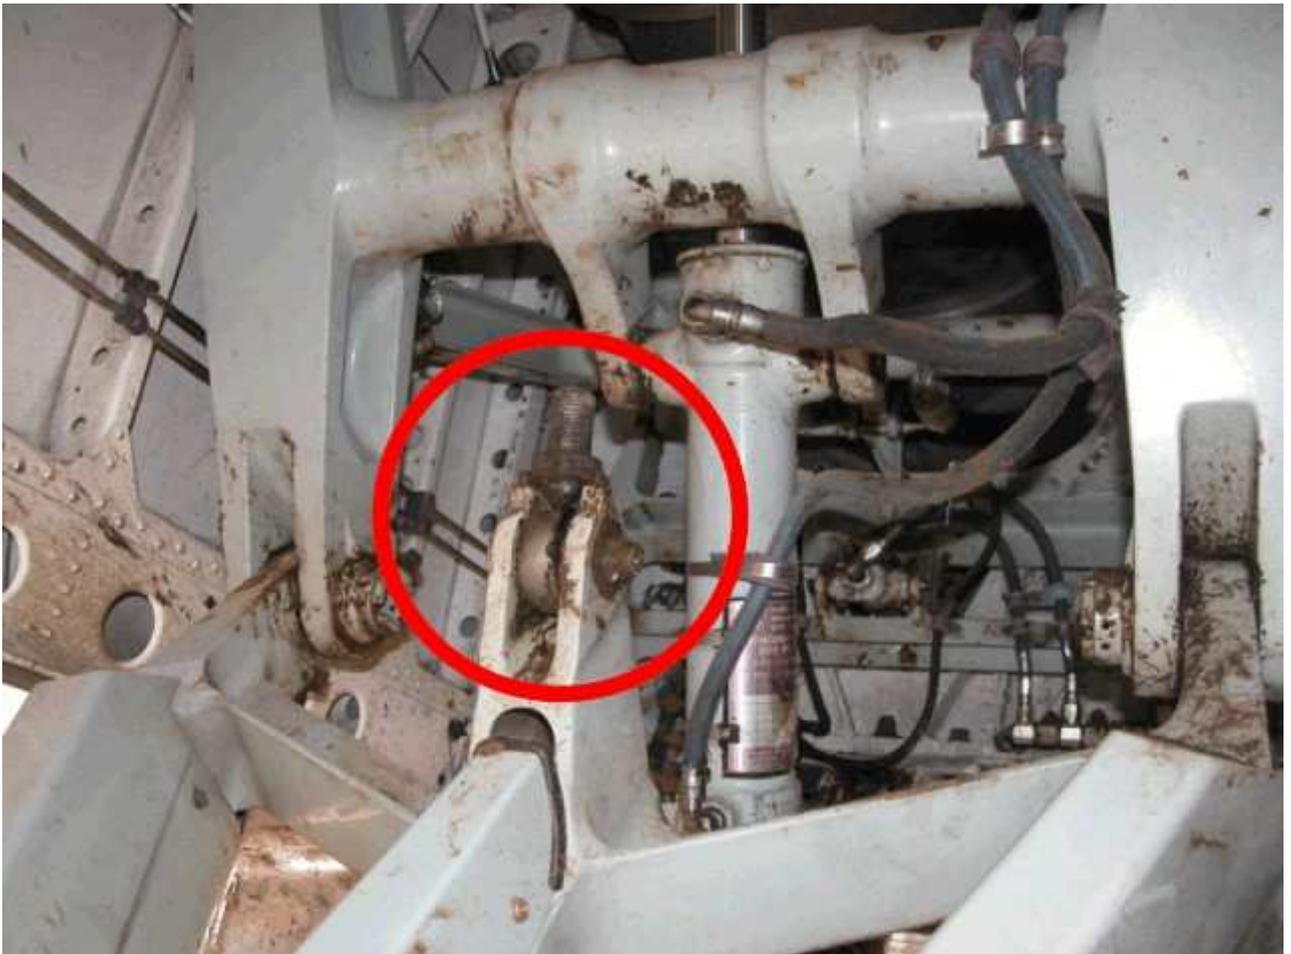
Figure 1: View of separated rod end.

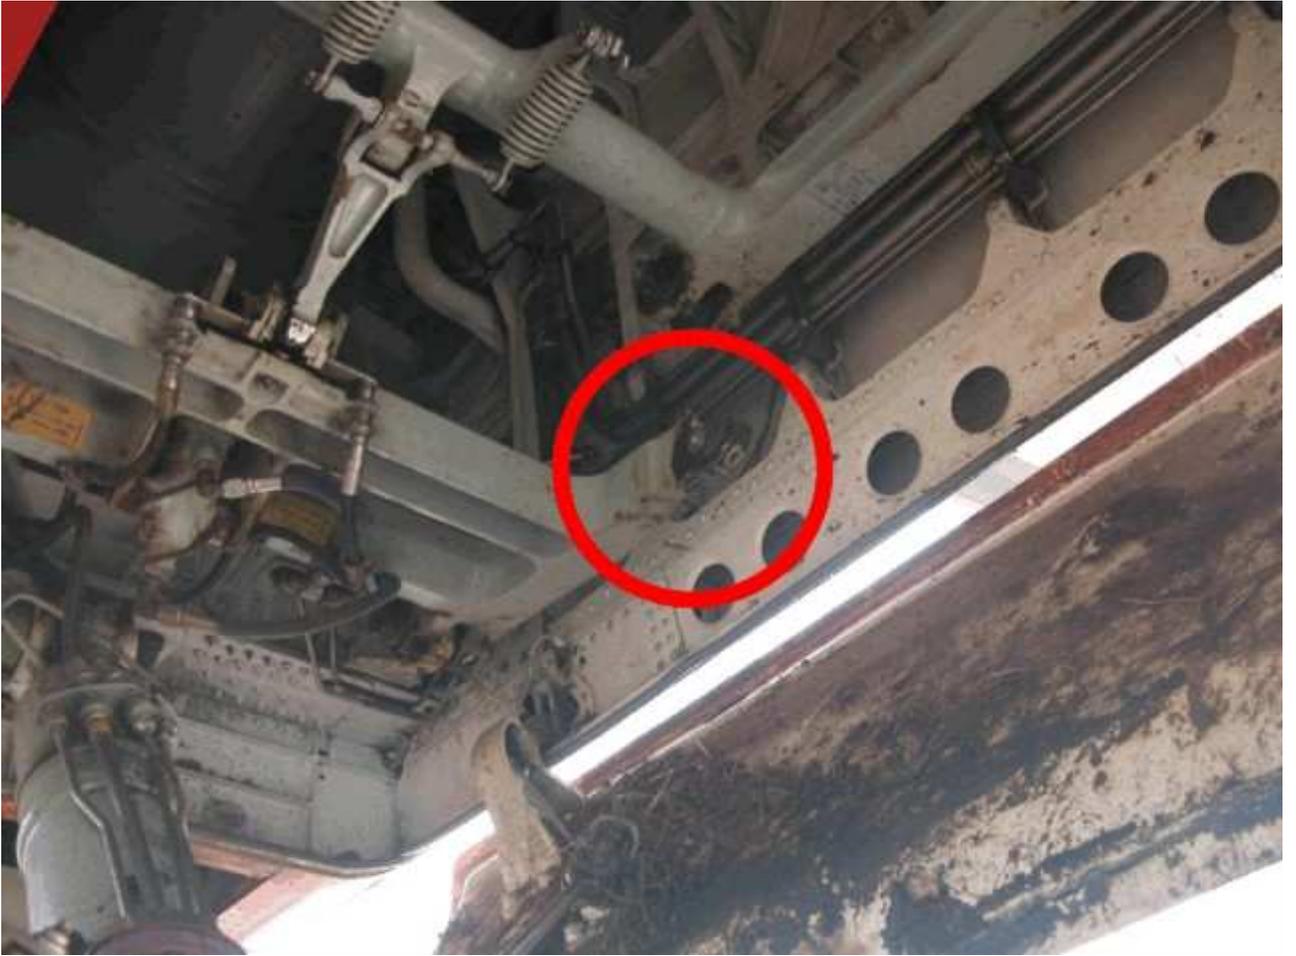
Figure 2: View of broken stabilizer brace assembly.

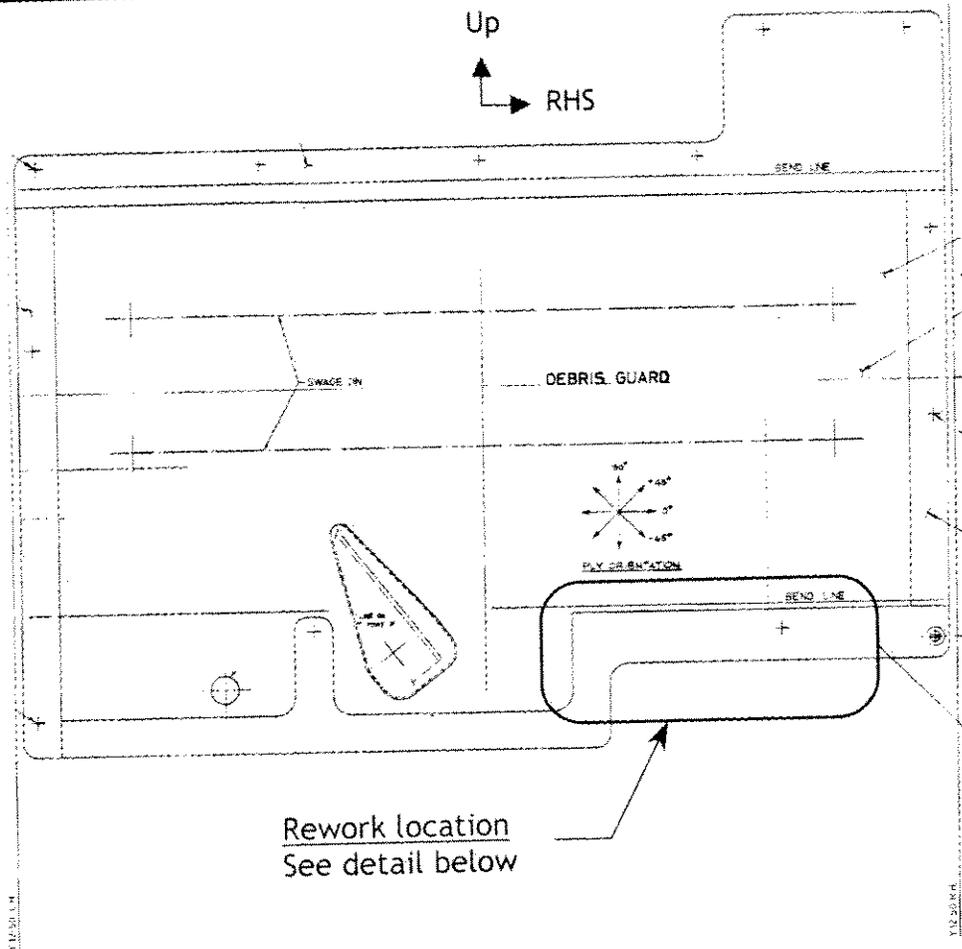
View looking fwd on debris guard showing location of rework
