**Redegørelse i anledning  
af tre havarier  
med Dash8 Q400**

**Bilag til redegørelsens kap. 6**

**Hæfte 1**

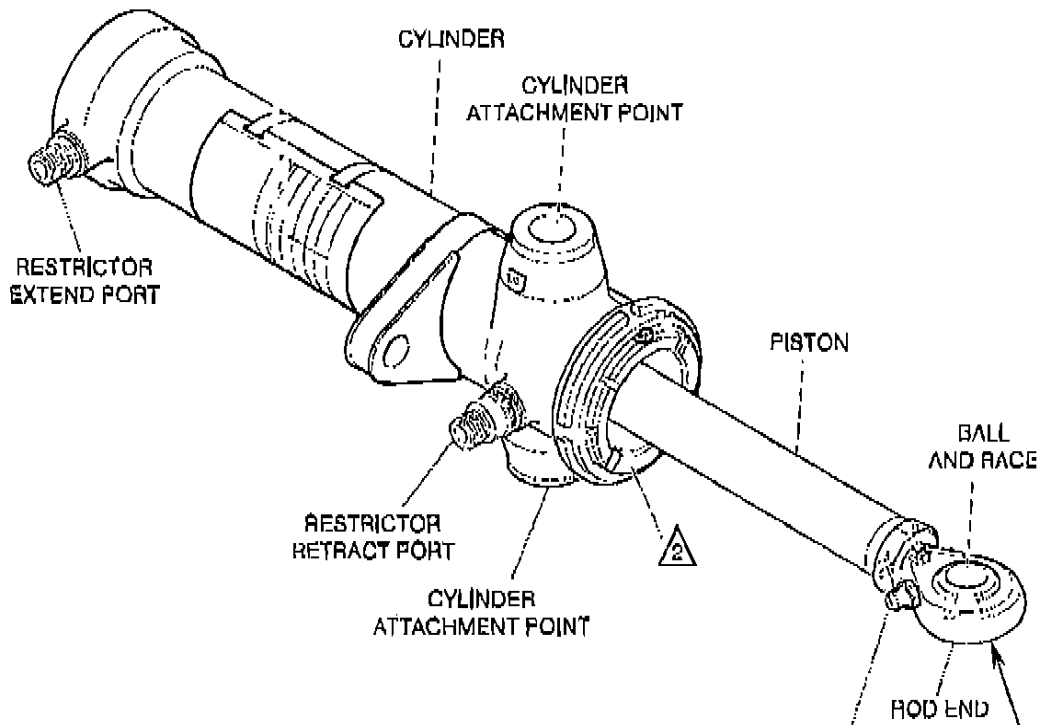
Retraction actuator assembly p/n 46550-7/-9

Inspect affected parts for any signs of corrosion or wear.

No corrosion or wear damage is allowed, *EXCEPT AS NOTED IN SCR 086-07 REV. A.* Provided the components are free of any damage re-assemble retraction actuator in accordance with SCR 086-07 rev. ~~REV. A.~~

Remove the rod end of the retraction actuator assembly in accordance with SCR 086-07 rev. ~~REV. A.~~

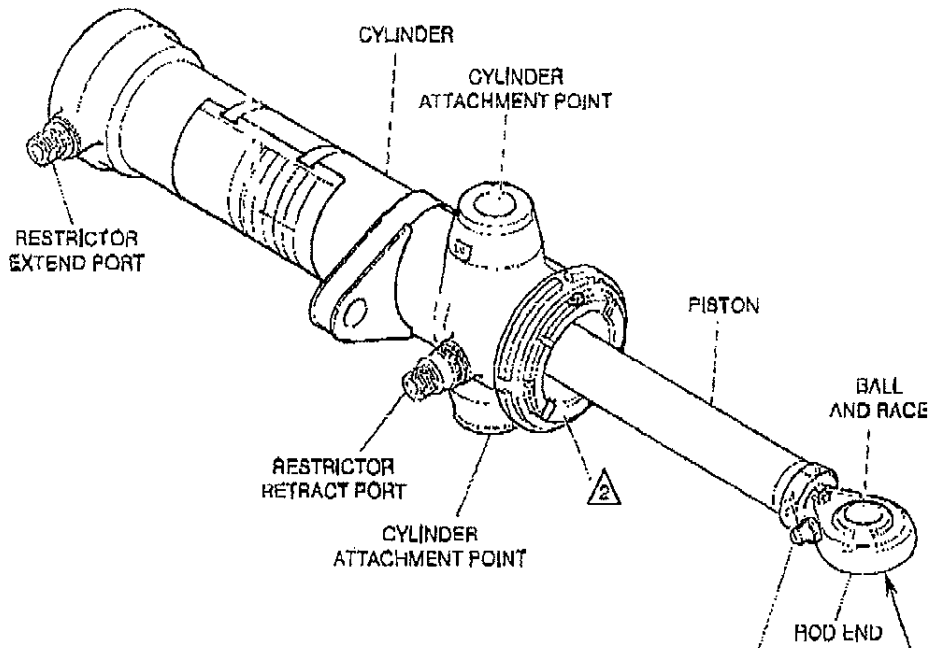
Retraction actuator assembly p/n 46550-7/-9

Inspect affected parts for any signs of corrosion or wear.

No corrosion or wear damage is allowed, EXCEPT AS NOTED IN SCR 086-07 REV. ~~A~~ B  
 Provided the components are free of any damage re-assemble retraction actuator in accordance with SCR 086-07 rev. ~~A~~ B

Remove the rod end of the retraction actuator assembly in accordance with SCR 086-07 rev. ~~A~~ B

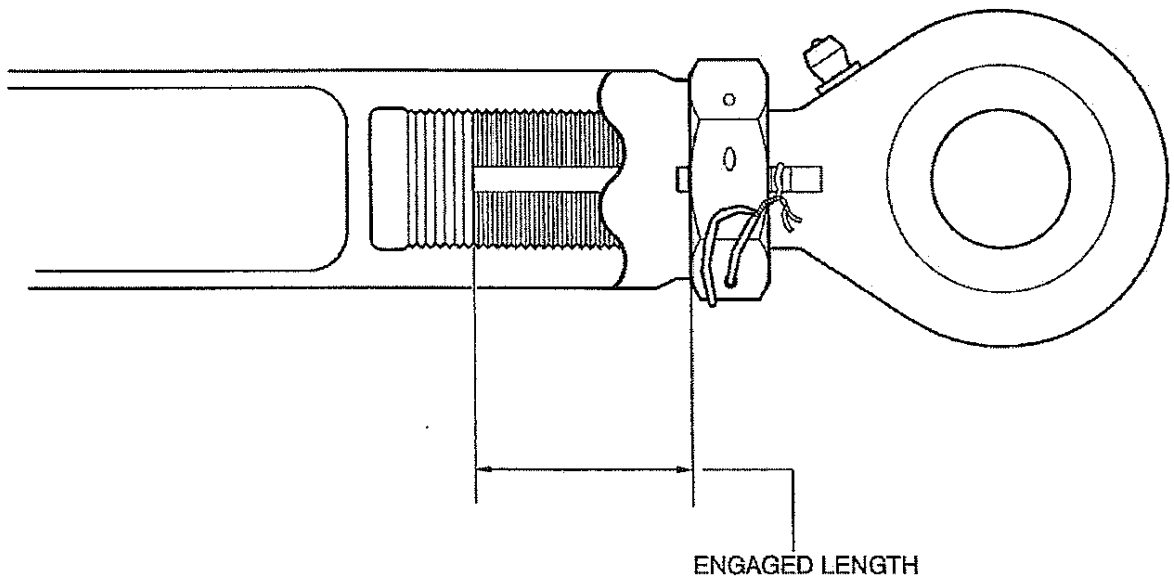
**FIGURE 2**

4. **ACCEPTANCE CRITERIA**
  - A) LIGHT SURFACE CORROSION (NO PITTING) OVER THE ENTIRE THREADED LENGTH WITH AT LEAST FIVE CONSECUTIVE FULL UNDAMAGED THREADS WITHIN THE ENGAGED THREAD LENGTH (REF FIGURE 2) IS ACCEPTABLE FOR **1000 FC OR 6 MONTHS** (WHICH EVER OCCURS FIRST) OF CONTINUED SERVICE. RETRACT ACTUATOR TO BE INSPECTED TO ENSURE JAM NUT IS SECURE AND WIRE LOCK IS IN PLACE EVERY **100 FC**.
