# Limfjord tunnel Assessment and retrofitting

Technical Summary Report, Version 1.0

Date 25. juni 2019

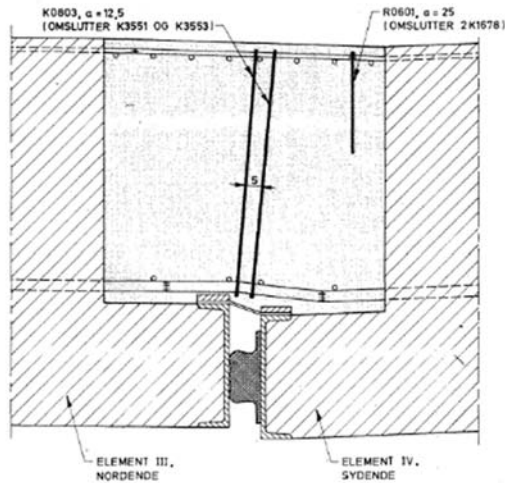
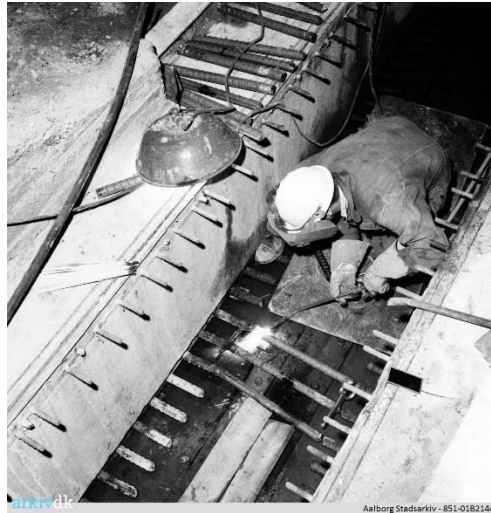
Figure 4.3-8 Immersion joint. The joint shown is between elements III and IV where additional reinforcement was installed due to the not perfect alignment.

The joints created a monolithic tunnel structure from the cast-in-situ tunnel to the northern portal building. Available information indicate that the immersion joints have all been successful as in general no water leakages have been reported in connection to the joints.

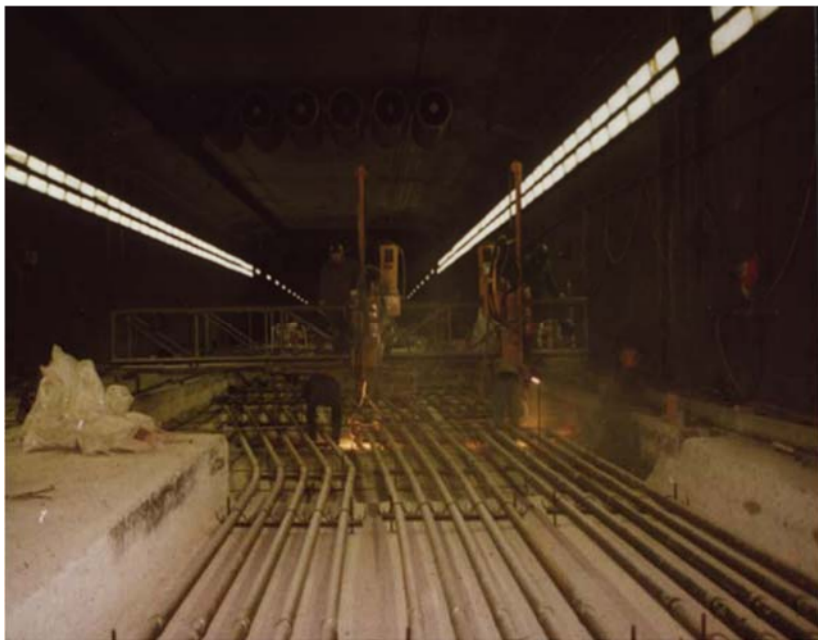
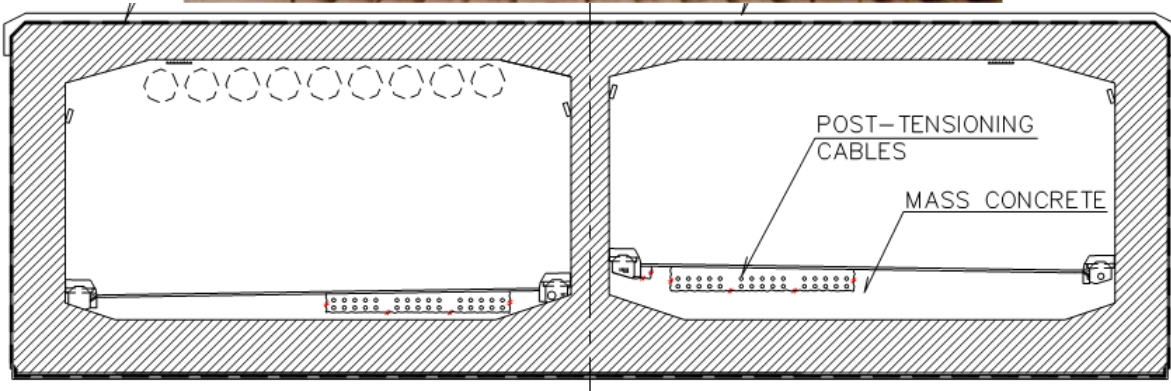
**Figure 4.5-2 Typical cross section with post tensioning cables installed in ballast concrete in 1993 – 1994.**

The tensioning of the tunnel with post tensioning cables installed in the ballast concrete in 1993-94 was carried out with the purpose to reduce the longitudinal tensile stresses and close through going cracks and thereby limit/stop water leakage. The Ultimate Limit State (ULS) structural capacity in the longitudinal direction was increased due to the additional post tensioning cables and thereby increasing the robustness of the tunnel. The location of the post tensioning cables is shown on [Figure 4.5-2](#).

The deformations of the tunnel due to the seasonal temperature variations resulted, before the tensioning of the tunnel cross section, in a slow increase of the tunnel length corresponding to approximately 1 mm per year. After the installation of the cables in 1993 – 1994 the yearly increase in length has in general been stopped.

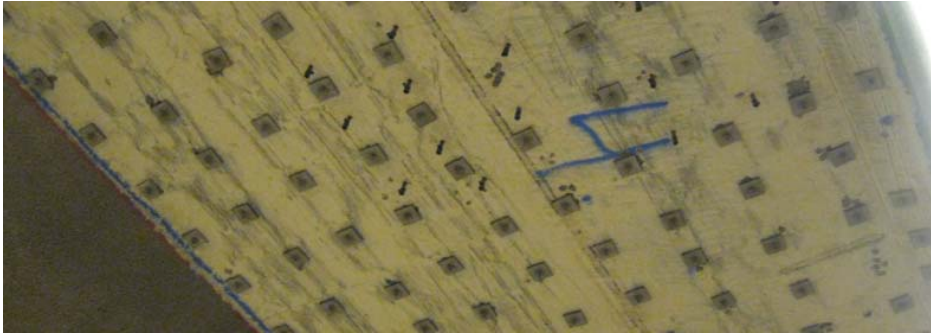
A large part of the 1998 repaired concrete in the tunnel ceiling was retrofitted in 2010 - 2011 with adhesive anchors between the repair and original concrete as delamination was observed between the repair and original concrete. This retrofitting inclusive a reassessment of the structural capacity of the repaired section is described in Section 7.5.5.

Figure 4.5-3 Installation of adhesive anchors in tunnel ceiling to make a structural connection between repair concrete and original concrete

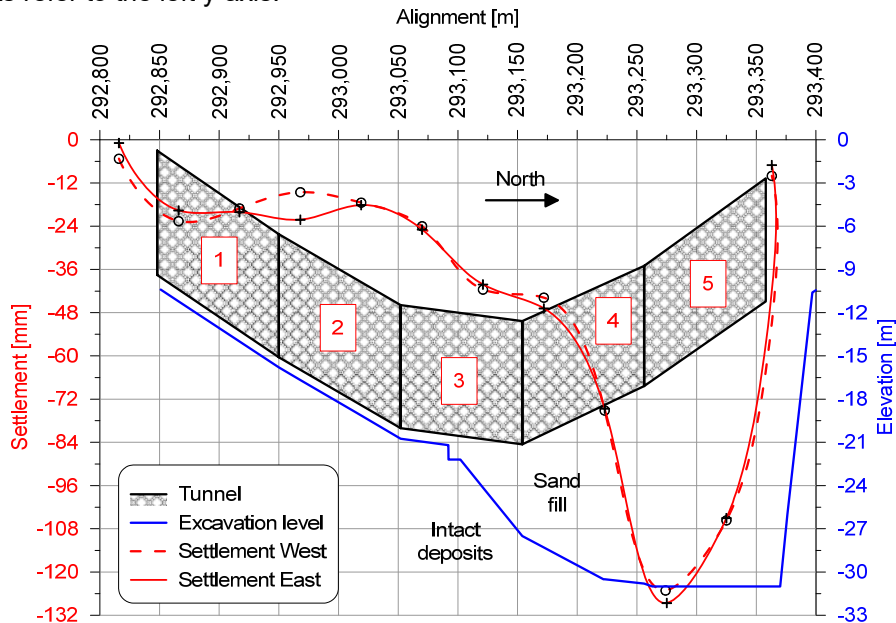
- The location of tunnel elements along the alignment. The elevation of the tunnel elements refers to the right y-axis.
- The excavation level to which Gytija was removed and replaced by sand fill.
- Observed settlements per December 2017 are also included for both tubes. The measurements refer to the left y-axis.

Figure 5.1-1 Tunnel elements along the alignment together with lower boundary for infilled sand.

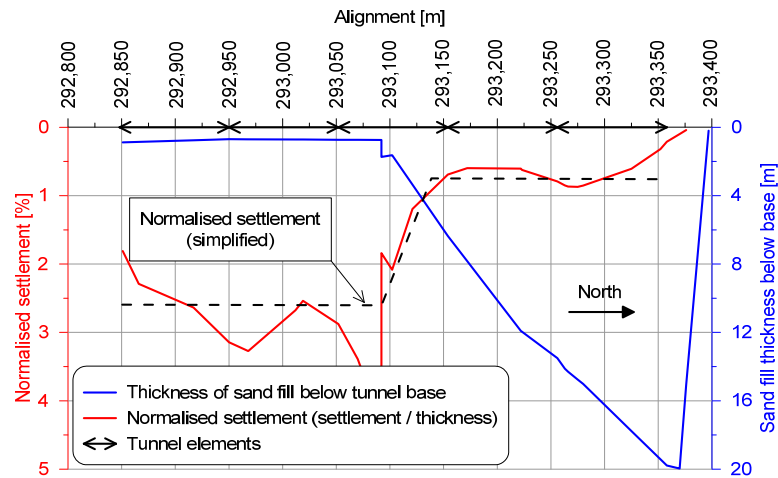
Figure 5.1-2: Thickness of sand fill below tunnel base and normalised settlement of tunnel as per December 2017.

Figure 5.1-2 shows that the normalised settlements are almost constant along the part of the tunnel being placed on sand fill, and this observation served as the working thesis for the geotechnical expert group during the project period.

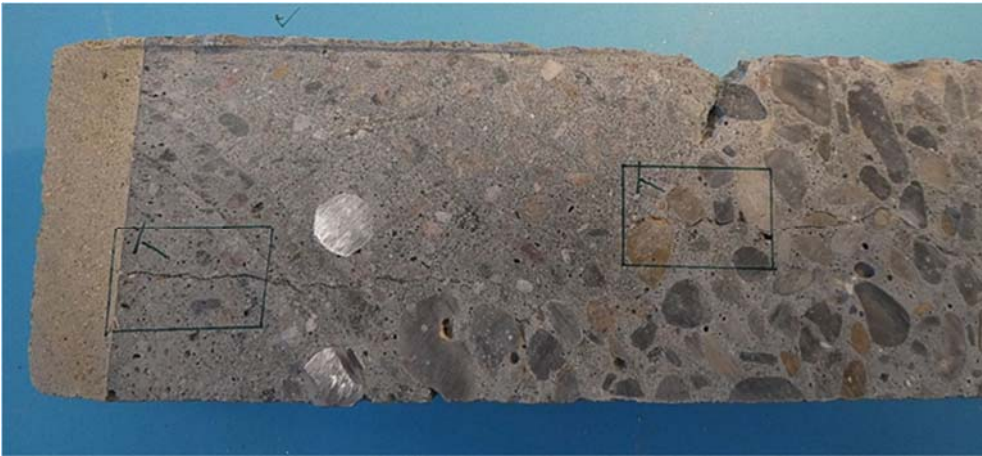
Figure 6.1-1 A concrete core from the roof has been cut in half in order to prepare for extraction of two thin sections (T).

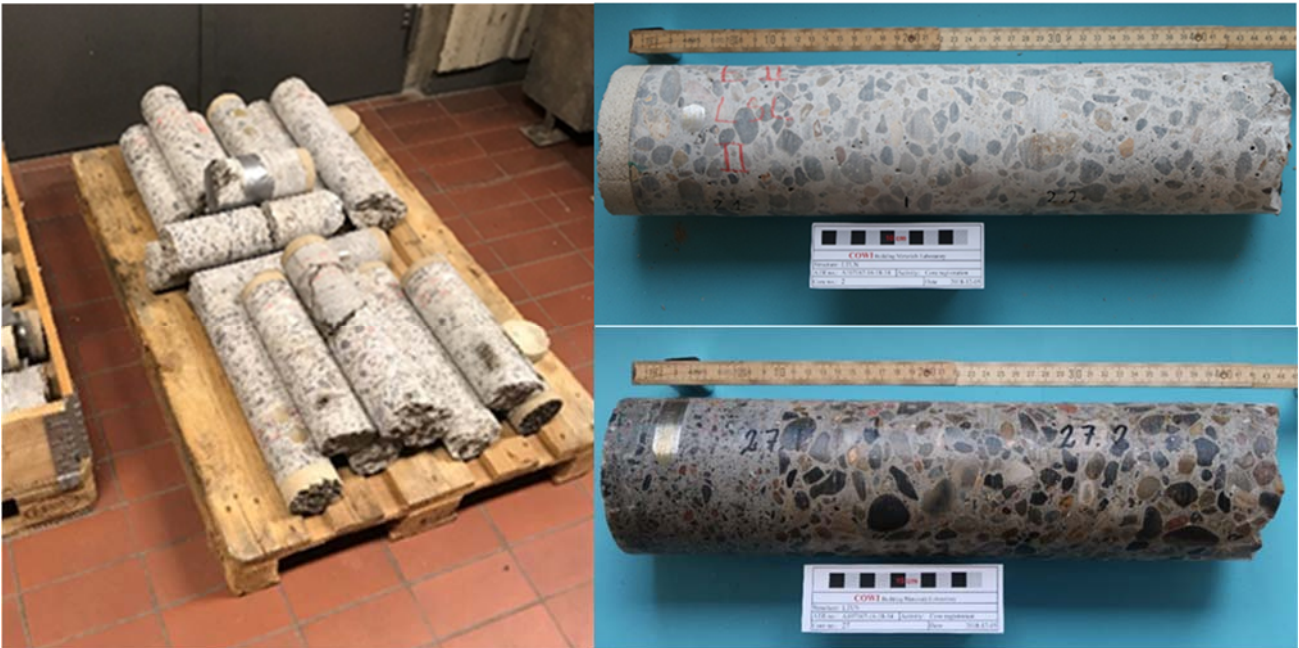
Figure 6.1-2 Cores extracted from wall (cores without fire protection) and roof (cores with fire proofing).

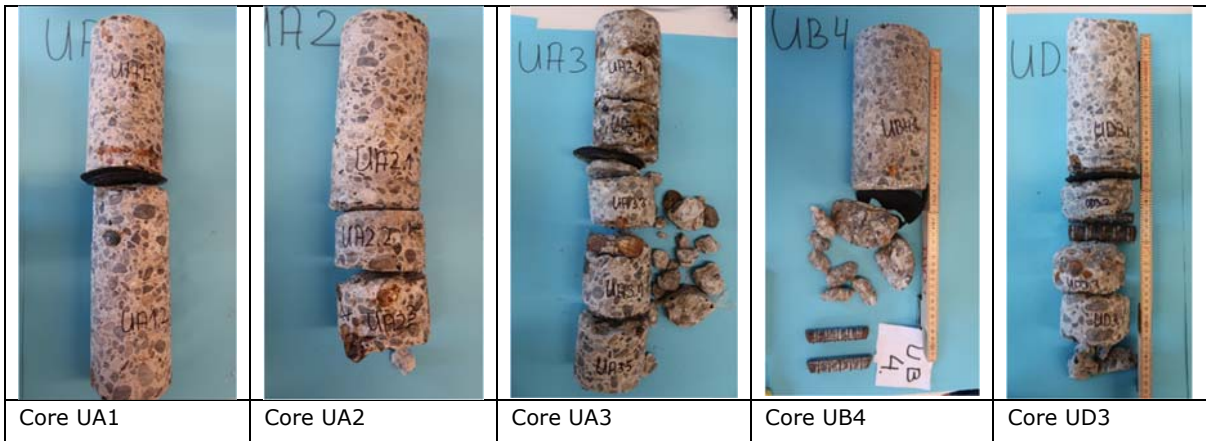
Figure 6.3-1 indicates that it was not possible to collect intact cores, which is assessed to be related to the difficult coring conditions and not the concrete quality. Generally, the protective concrete is seen at the top of the cores while the structural concrete is seen at bottom of the cores. The membrane can be seen between the two concrete layers in four of the five cores.

Protective concrete layer: The concrete generally consists of materials of good quality. Some alkali silica reactive particles have been observed but no damaging reactions have been observed.

The chloride content of the concrete is higher than 0,3 % chloride (by weight of concrete) throughout the layer. The rebars do not show any significant signs of corrosion despite the high chloride content. This is most probably due to lack of oxygen. Pitting corrosion cannot be excluded, but no signs have been observed. Generally, the risk of pitting corrosion is assessed to be low.

Figure 6.3-1 The five cores taken from the outside of the Limfjord Tunnel. The cores were taken from three different areas UA, UB and UD.

Waterproofing membrane: No signs of adhesion to either the underlying structural concrete or the protective concrete above have been observed. The membrane appears intact but has no to limited adhesion between the individual membrane layers.

Structural concrete layer: The concrete generally consists of materials of good quality, but some reactive particles have been observed. Some ASR-gel is present in cracks and voids, but no damaging reactions have been observed.

The chloride content appears high (between 0,16 and 0,78 % by weight of concrete) near the exposed surface (membrane side). A chloride content above the threshold value (0,1 % by concrete weight) is seen at reinforcement level. The rebars do not show any significant signs of corrosion despite the high chloride content. This may be due to lack of oxygen. Pitting corrosion cannot be excluded, but no signs have been observed.

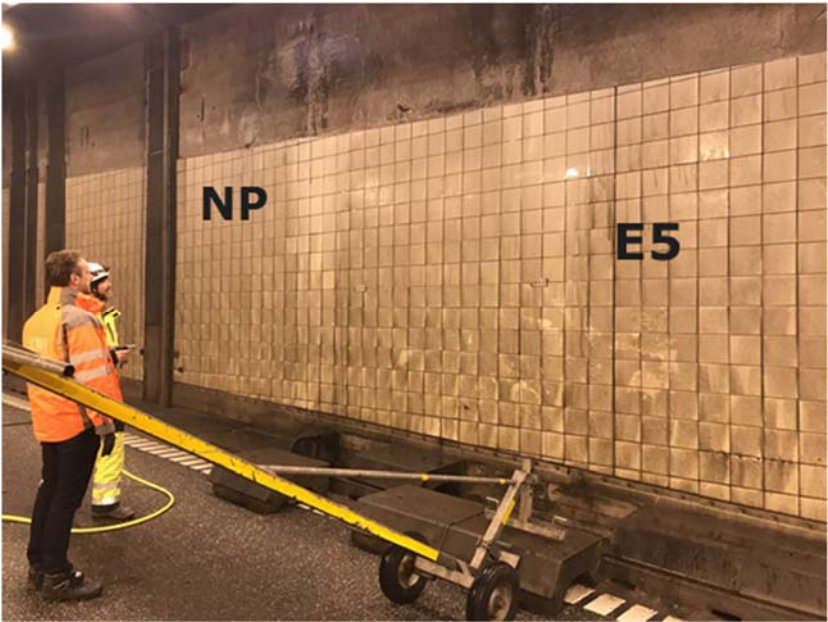
Figure 6.7-1 Closure joint between Northern Portal (NP) and Element V (E5) before removing tiles and concrete in order to inspect the reinforcement.

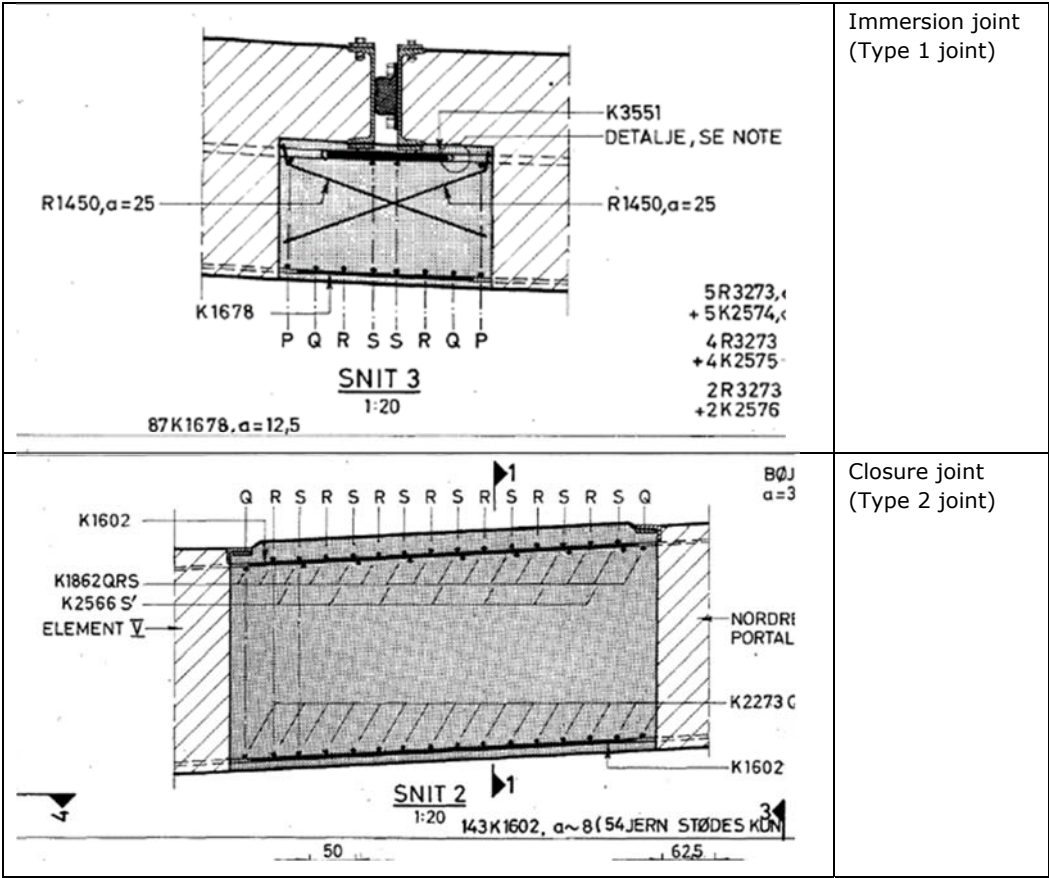
The immersion joints and closure joint have been given special attention. The main concern has been the condition of the welded connections that secures the transfer of forces in the horizontal reinforcement through the five normal immersion joints and the special closure joint between element V and the in-situ build part of the northern portal structure. The layout of the two types of joint is shown in [Figure 6.7-2](#).

Figure 6.7-2 Layout of immersion joints and closure joint.

It was decided to concentrate inspections on the closure joint as this is the most critical joint. The inner layers of the reinforcement were exposed by means of water jetting at a rather large part of the closure joint.

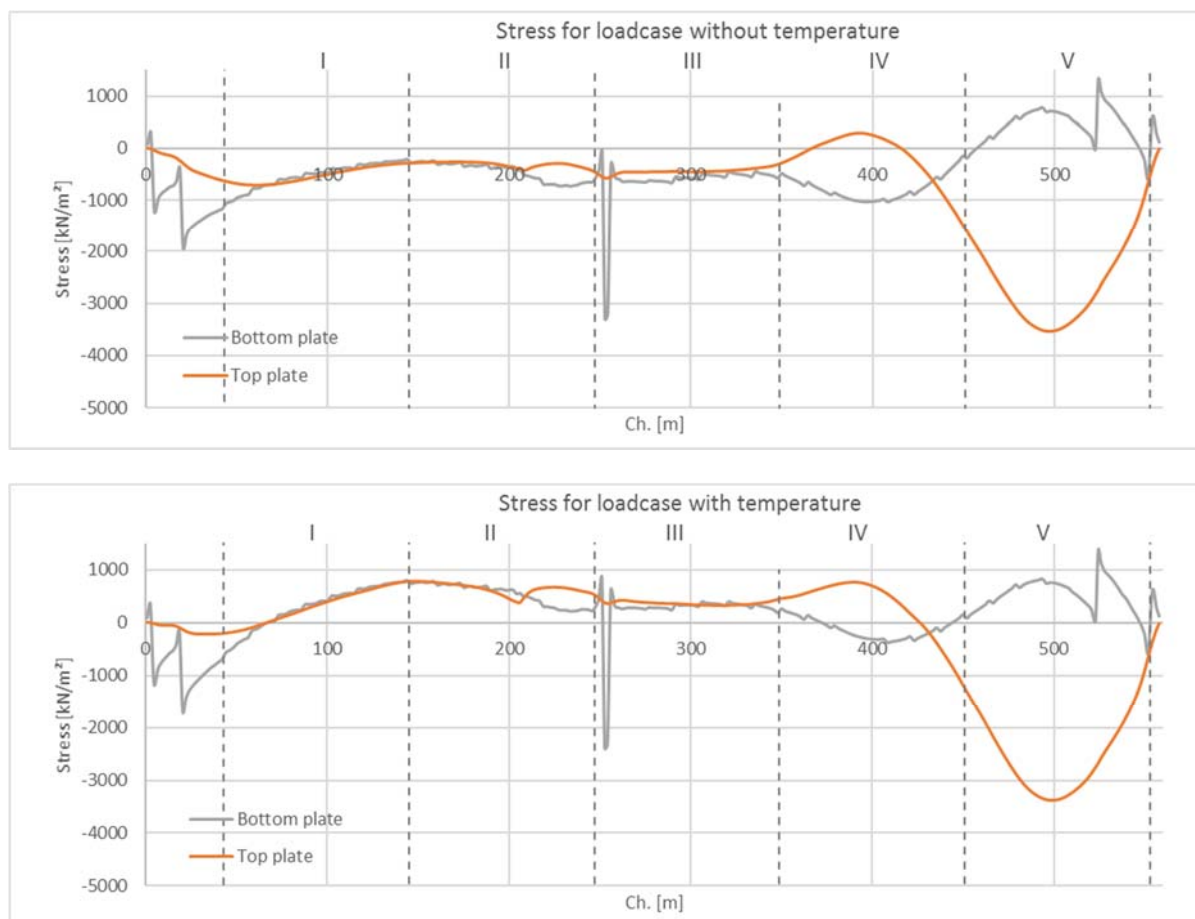
The peak stresses for tunnel element IV and V clearly reflect the significant sagging and hogging moments caused by the settlements. The discontinuous curve for the bottom slab reflects the locations where the post-tensioning forces are applied (anchorage points).

Figure 7.4-2 Model 1, Base model (year 2017). Concrete stresses in top and bottom slab, upper figure without temperature, lower figure with temperature. Alignment 0 is located at the southern expansion joint corresponding to the global alignment 292.805.

It is also clearly seen how the temperature contribution (contraction) increases the tensile stresses significantly and brings the main part of top slab / roof into tension, although post-tensioning has been installed. This means that post-tensioning is not fully efficient with regards to closing the cracks and keeping the cross-sections permanently under compression. Hence, the water is still able to penetrate the existing cracks caused by early age thermal effect / shrinkage and further developed by axial tension from temperature effects before prestressing was applied. That is why leakages are still seen every year, although the tensile stresses are generally lower than the tensile strength. In other words, the cross-sections are not able to satisfy the crack width criteria to ensure a watertight structure (SLS).

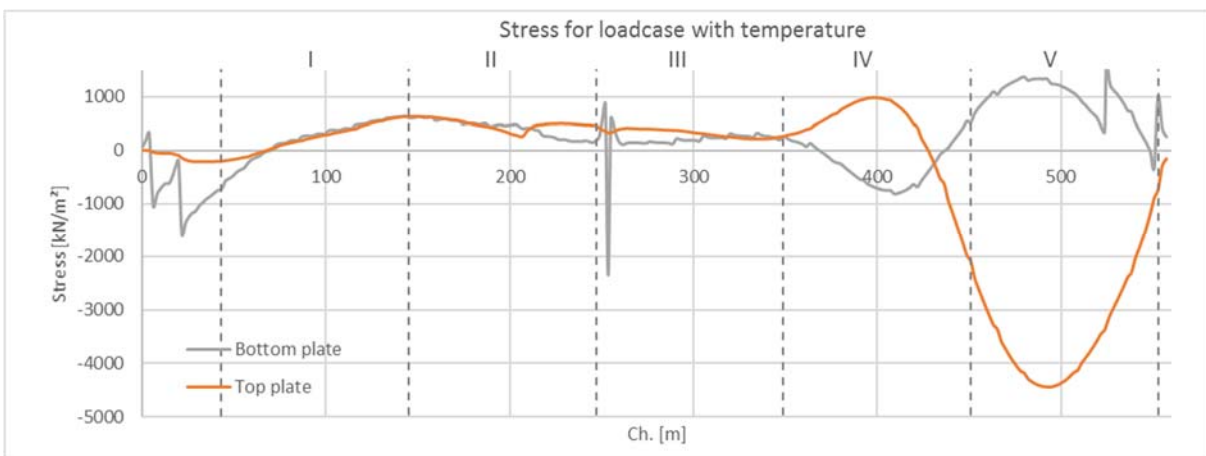
Figure 7.4-3 Model 4, Future scenario (year 2069), increased settlements, Stresses in top and bottom slab including temperature

In Figure 7.4-3 the similar stresses are shown for the future situation in year 2069 with increased settlements. Obviously, the tensile stresses both in the top slab and the bottom slab are increased, but the corresponding reinforcement stresses are well below the design yielding strength when applying safety factors in Ultimate Limit State (ULS). However, with regards to leakages, an increase might be expected in the future because of an increase of the tensile stresses mainly in tunnel element IV and V.

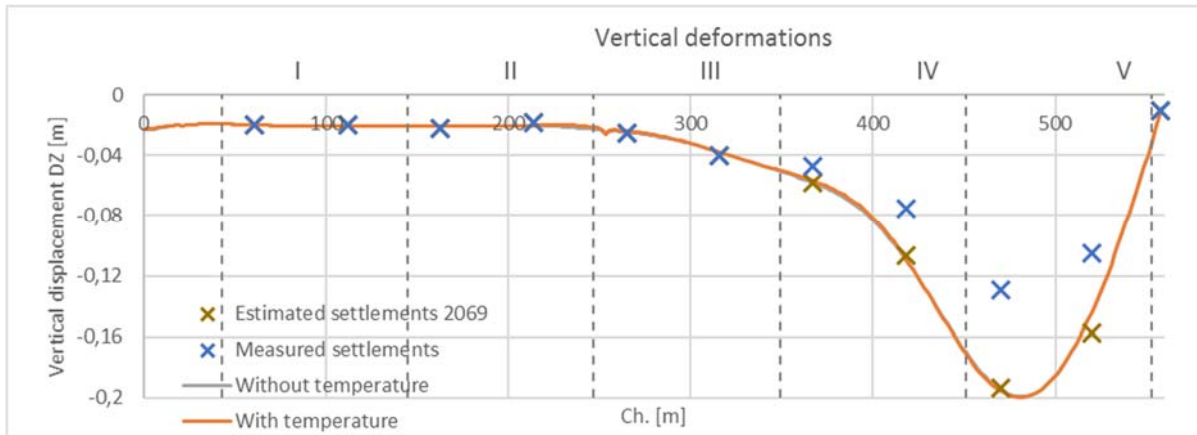
The future scenario of differential settlements shown on Figure 7.4-4 is based on a conservative extrapolation of the current settlements with increase of approx. 60 mm (at point of max) in the next 50 years. An additional 30 mm is added in the verifications, see Section 7.4.6.

Figure 7.4-4 Model 4, Future scenario (year 2069), increased settlements

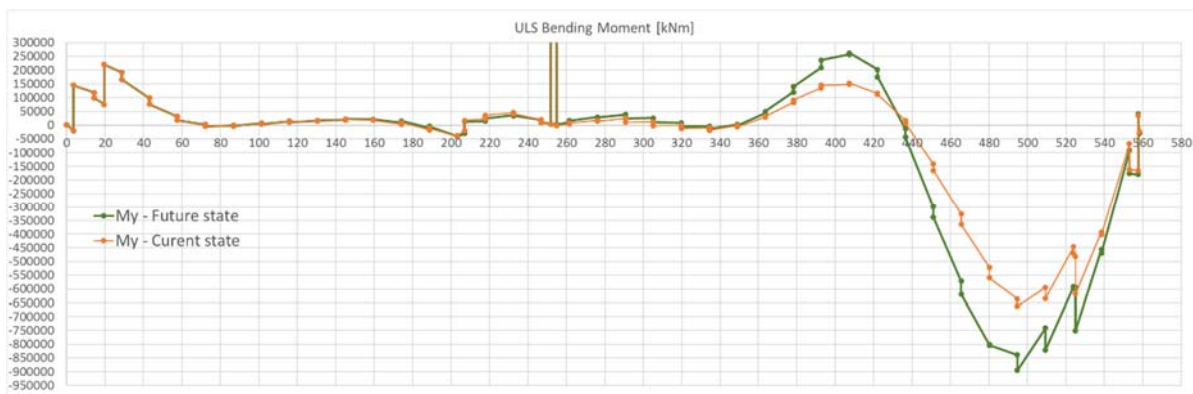
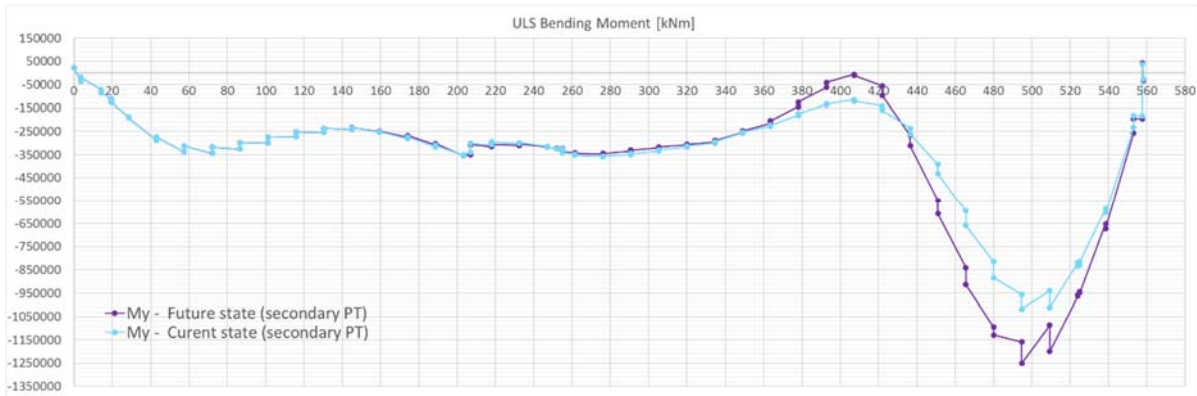
The design bending moment diagrams are shown in [Figure 7.4-5](#) and [Figure 7.4-6](#) for both the future and current state. The difference between the diagrams in the two figures is the first one considers the post-tensioning on the load effect side only, while the other one considers only the secondary effects of post-tensioning on load effect side. The most critical of the values from the two figures have been used for calculating the utilization ratios.

The bending moment capacities have been calculated assuming fully embedded prestressing cables, which is actually not the case. The cables are only structurally connected to the tunnel in the anchorage zones and where the deviators are placed. Therefore, reduced bending capacities corresponding to the yield strength ( $f_{p0,1k}$ ) have been calculated as well, see [Table 7.4-1](#). And the utilization ratios are determined based on the latter. For more details reference is made to Appendix 3 of Longitudinal indicative analyses [9].

Figure 7.4-5 Bending moment in longitudinal direction, ULS combination values (total PT), current and 2069 state

Figure 7.4-6 Bending moment in longitudinal direction, ULS combination values (Secondary PT), current and 2069 state

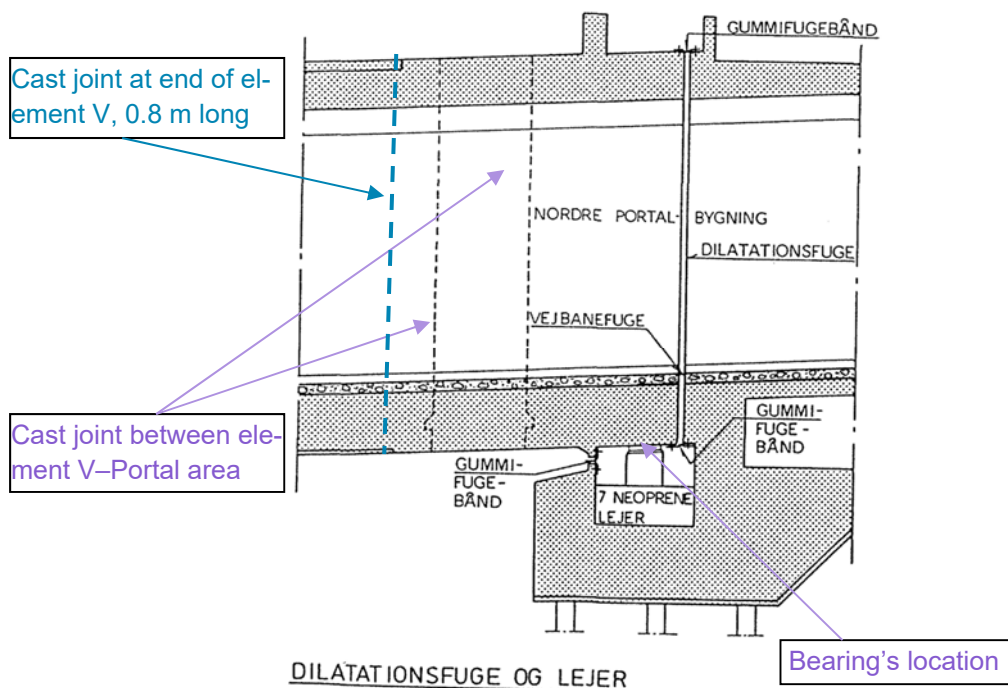
The utilization ratios for the shear capacity verifications for construction joints are shown in Table 7.4-2. The most critical vertical construction joint with regards to shear capacity is the closure joint type 2 connecting tunnel element V and the last part of the tunnel that was constructed together with northern portal building, see Figure 7.4-7. For more details, reference is made to section 6 in Appendix 3 of Longitudinal indicative analyses [9].

Figure 7.4-7 Geometry of northern end of the tunnel (Closure Joint type 2)

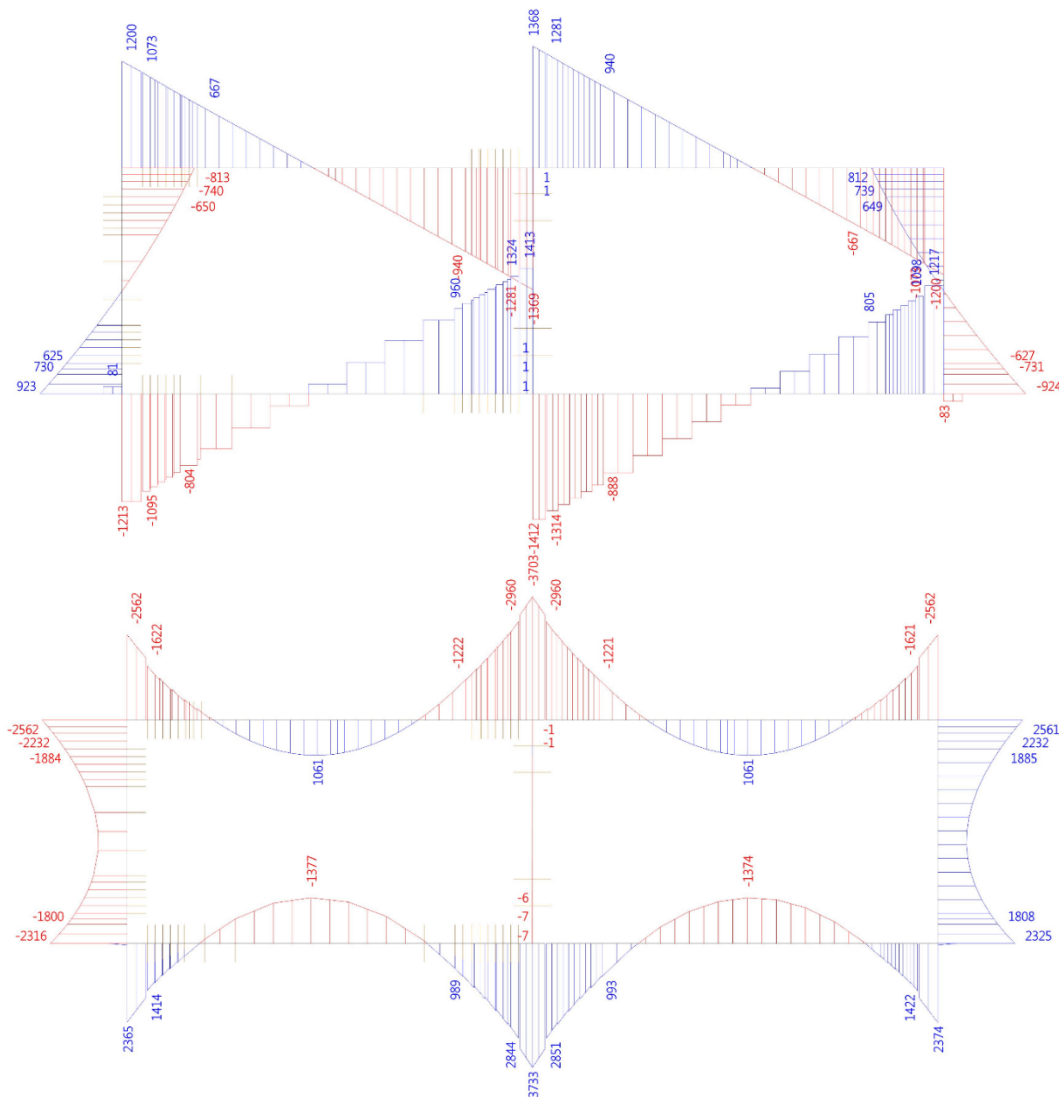
The shear and bending moment diagrams for ultimate limit state, ULS, are shown for the most critical section (293060) in [Figure 7.5-3](#). The location of the section is shown on [Figure 7.5-1](#).

**Figure 7.5-3** Shear force and bending moment diagrams, ULS, section 293060

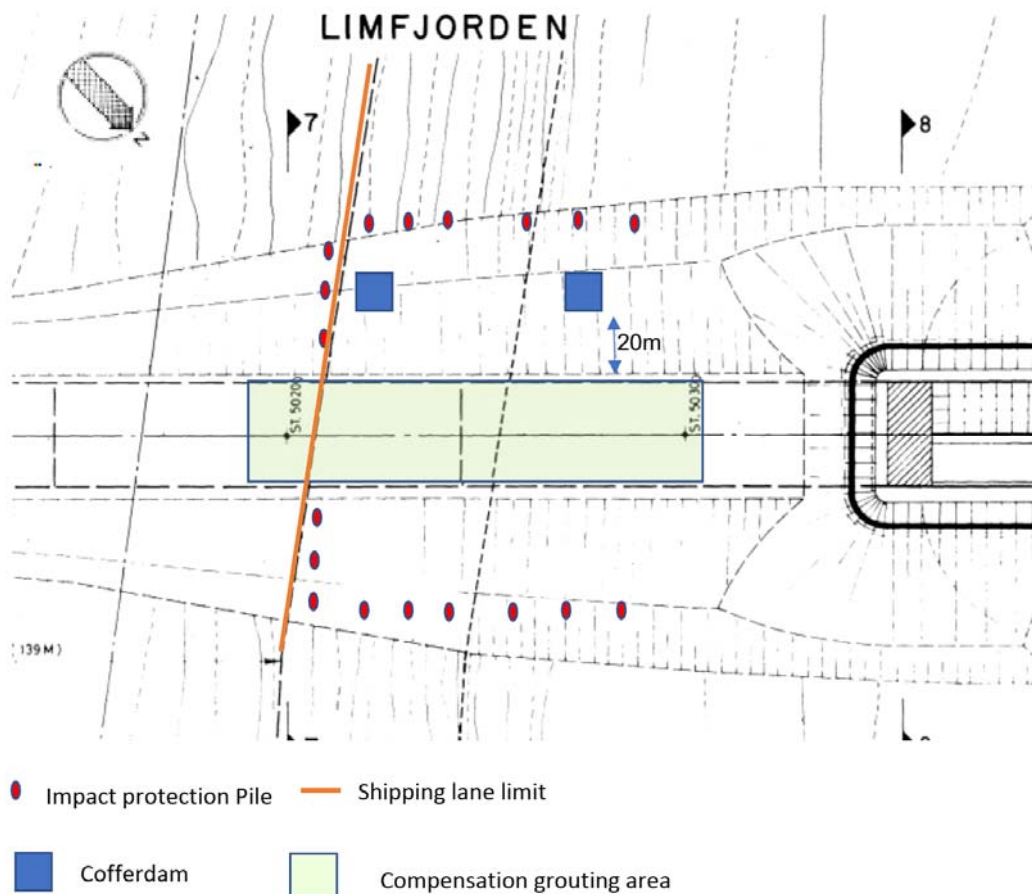
Figure 9.2-1 Indicative plan showing cofferdams and ship protection piles.

Control of the grouting can be very selective inducing very small level changes of varying amounts to reduce the risk of inducing further stress in the tunnel structure. The compensation grouting treatment would be installed from the midpoint of element IV to approximately 25m from the Northern Portal (i.e. 125m long over the full width over the tunnel) as shown in [Figure 9.2-1](#) and [Figure 9.2-2](#).

3. Installing ship impact protection piles to provide protection to the cofferdams during the grouting process. See [Figure 9.2-1](#)
4. Installing two levels of horizontal grout injection tubes to a pre-determined pattern under the structure. See [Figure 9.2-2](#) and [Figure 9.2-3](#). The drilling techniques to be adopted will address the high water pressures and poor ground conditions that will be present at this level.

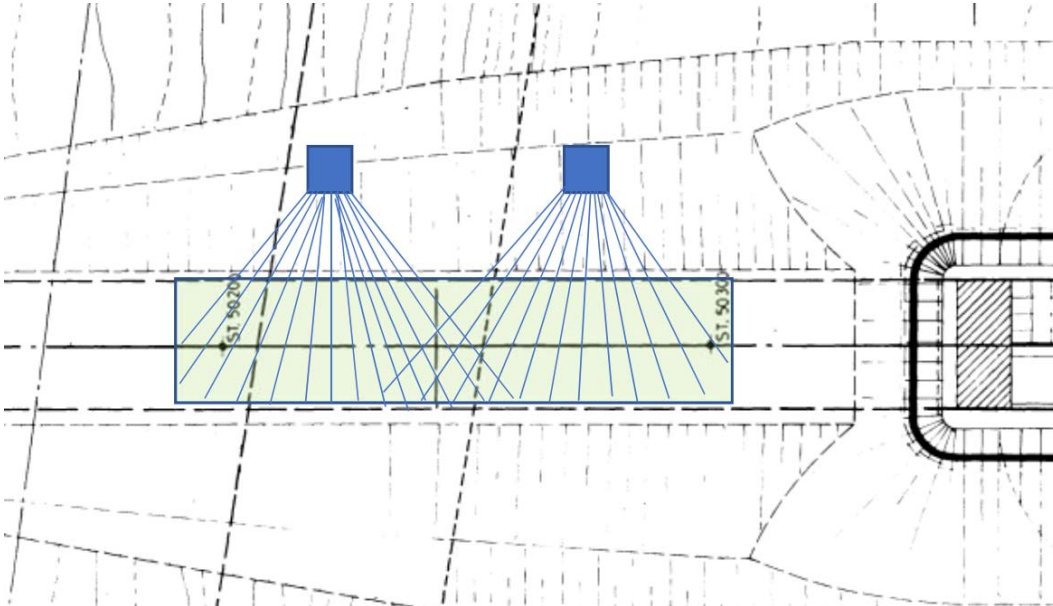
Figure 9.2-2 Plan showing indicative layout of grout injection tubes.

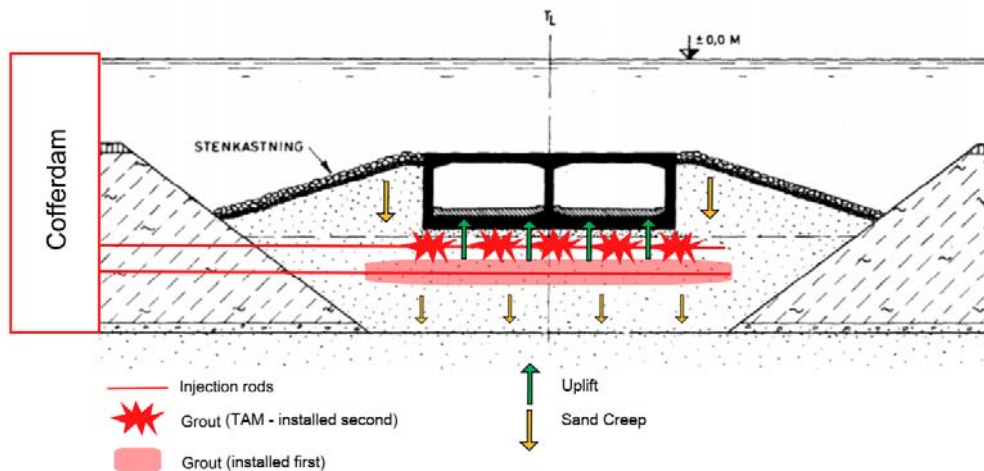
Figure 9.2-3 Section showing indicative pre-treatment and compensation grout injection tubes.

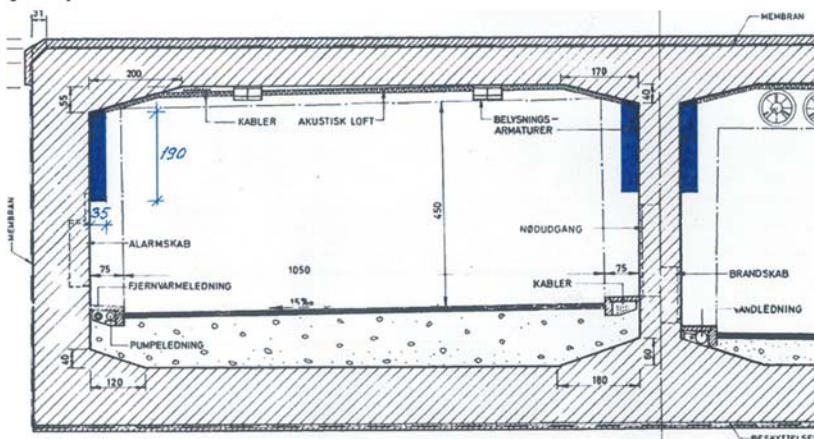
[Figure 9.3-1](#) Spaces available for installations such as external post tensioning cables (blue colour) along upper part of all wall surfaces.

The available spaces are assumed used for placing a number of external post tensioning cables. External cables are often used for strengthening of existing structures and the solution is considered well proven technology even though the use in an immersed tunnel may be unusual.

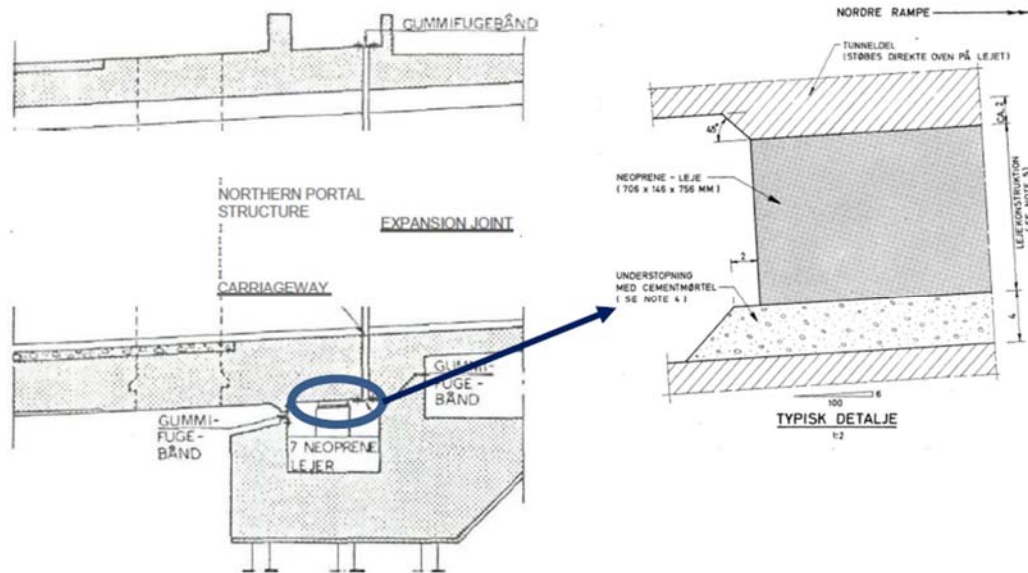
The bearing blocks located in the northern portal building are dimensions 706 x 756 x 146 mm<sup>3</sup>. The thickness of the grout pad under the bearing blocks is approximately 40 mm.

Figure 9.3-3 Existing bearing blocks in northern portal building.

These bearing blocks can be replaced with new bearing blocks with less height and with a Teflon layer included. The possible reduction in height may not be more than approx. 20 mm, but more lowering can be achieved by a small reduction in the height of the plinths below the bearing blocks. The height of the grout pad can also be reduced from 40 mm to approximately 20 mm. The possible lowering of the northern end of tunnel element V is thus at least say 90 - 100 mm (but circumstances as explained in the following may prevent such a big vertical displacement unless some special measures are introduced).

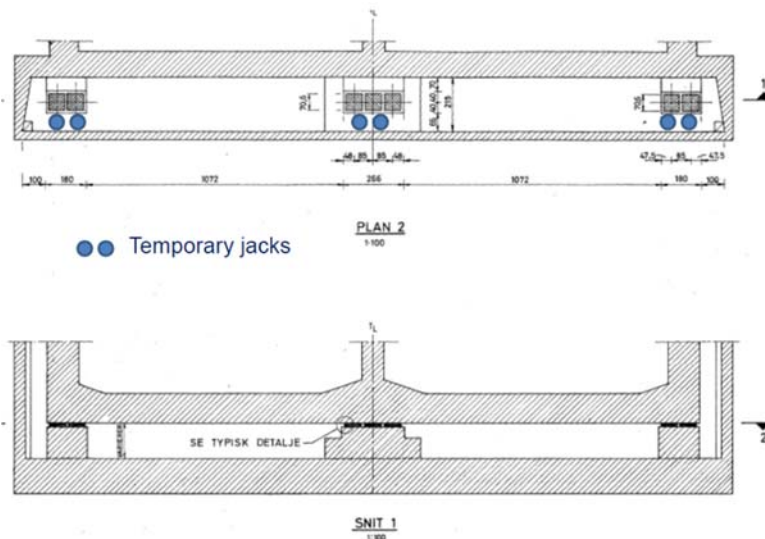
Figure 9.3-4 Location of temporary jacks during replacement of bearing blocks.

The temporary jacks can only be placed south of the bearings in the gap between the small front wall with the Omega seal expansion joint and the plinths. It means that the loads on the piles will be applied eccentrically.

Temporary jacks would be used to exchange the bearing blocks and during this operation to provide information regarding the current load and indirectly regarding the potential gap and the foundation bed mobilization. The jacks could also be used as part of the monitoring system.

Replacement of bearings by use of temporary jacks is often used, however mainly on bridges. It must be regarded as well proven technology even if it is not common practice in case of an immersed tube tunnel.

The replacement of the bearing blocks may be executed without much effect on the availability of the tunnel. It must however be considered if load transfer from bearings to jacks and vice versa is considered critical in respect of safety for the tunnel users. But these operations can maybe be executed during only night or weekend closures of the tunnel (the entire tunnel). The new Omega seal solution can be executed without any (or much) influence on the traffic. New expansion joints in the road surfaces will probably require the closure of each tunnel tube for approximately a week. New wedge-shaped transitions in the asphalt can be executed in parallel during such week. As the vertical displacement of the tunnel end will happen “over-night” some temporary transitions in the road surfaces will be necessary (together with a reduced speed of vehicles during the period).
