**Foreløbig redegørelse
i anledning af havarier
med Dash-8 Q400
9. og 12. september 2007**

Bilag til redegørelsens kap. 6

**Aircraft Accident Notification Report
SK1209/09SEP2007**

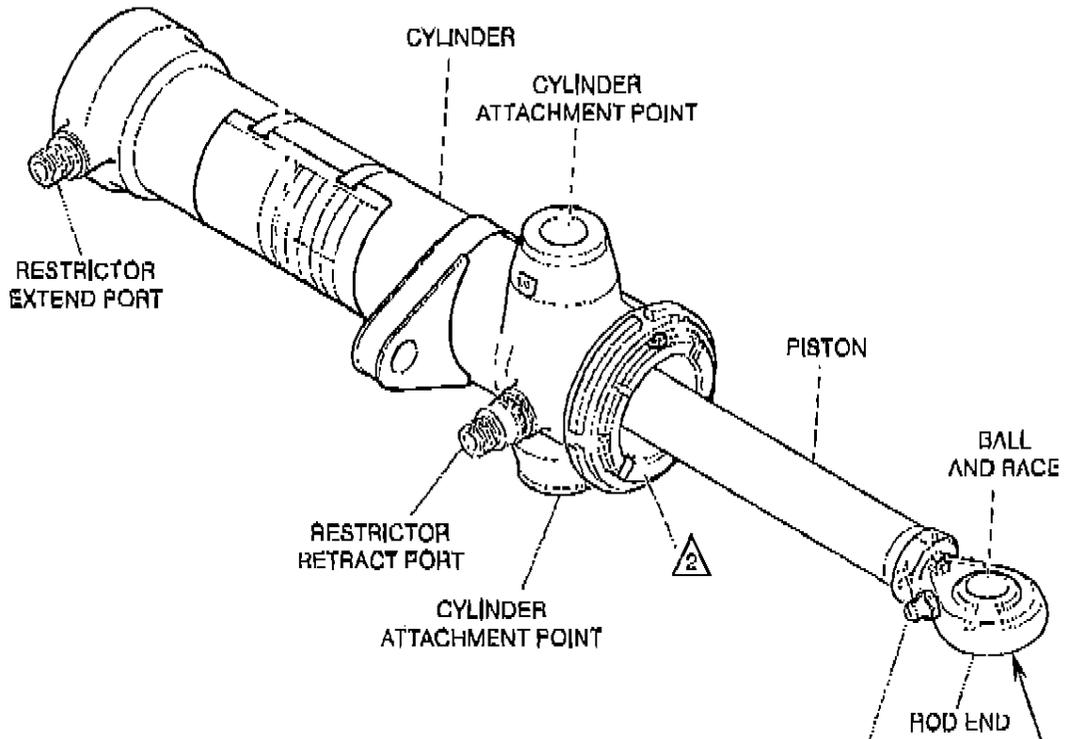
Retraction actuator assembly p/n 46550-7/-9

Inspect affected parts for any signs of corrosion or wear.

No corrosion or wear damage is allowed, *EXCEPT AS NOTED IN SCR 086-07 REV. A.* Provided the components are free of any damage re-assemble retraction actuator in accordance with SCR 086-07 rev. ~~REV~~ A.

Remove the rod end of the retraction actuator assembly in accordance with SCR 086-07 rev. ~~REV~~ A.

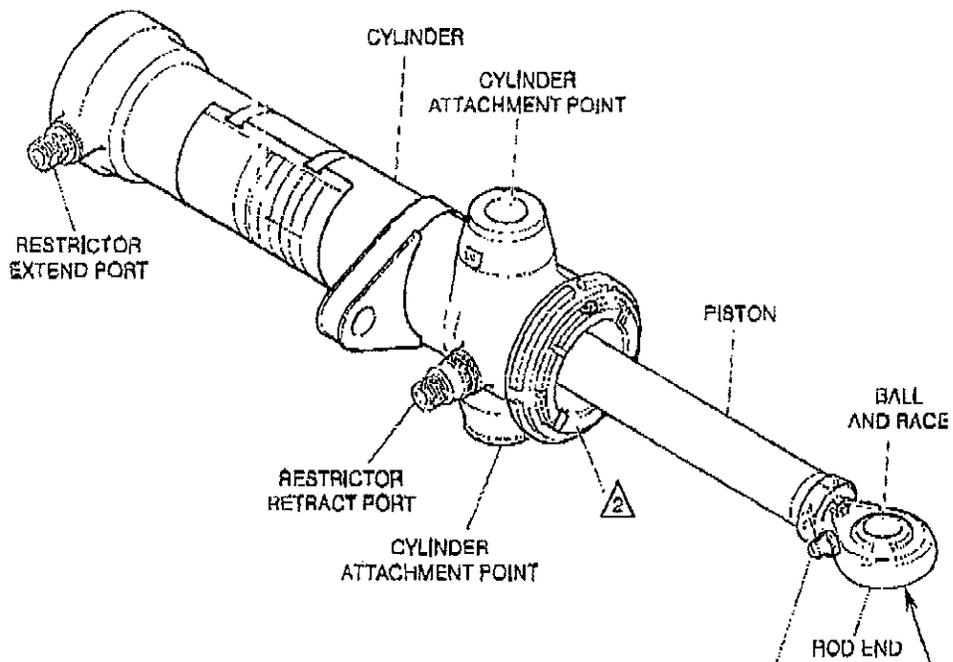
Retraction actuator assembly p/n 46550-7/-9

Inspect affected parts for any signs of corrosion or wear.

No corrosion or wear damage is allowed, EXCEPT AS NOTED IN SCR 086-07 REV. A B
 Provided the components are free of any damage re-assemble retraction actuator in accordance with SCR 086-07 rev. ~~RE A~~ B

Remove the rod end of the retraction actuator assembly in accordance with SCR 086-07 rev. ~~RE A~~ B

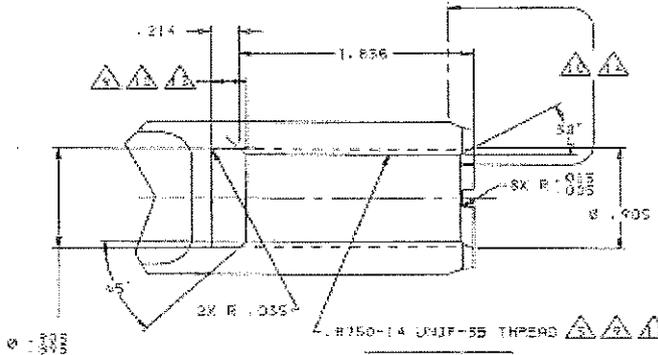
FIGURE 1

10. VISUALLY INSPECT PISTON (P/N 46570-1/-3) THREADS AND THREAD RELIEF AREA FOR EVIDENCE OF CORROSION AND/OR DAMAGE AND/OR PITTING (REF. FIGURE 1), USING A SMALL MIRROR UNDER ADEQUATE LIGHTING CONDITIONS. INSPECT WITH 10 X MAGNIFICATION MIRROR UNDER ADEQUATE LIGHTING CONDITIONS WITHIN **500 FC**

- IF CORROSION IS FOUND IN THREADED AREA OF PISTON P/N 46570-1/-3 PERFORM REWORK IN ACCORDANCE WITH **SECTION B** OF THIS SCR
 - IF NO CORROSION IS FOUND CONTINUE WITH REMAINING OPERATIONS

1. DISASSEMBLE AS REQUIRED TO REMOVE ROD END P/N P3A2750 FROM ACTUATOR ASSEMBLY.
2. INSPECT - ENSURE NO EVIDENCE OF CORROSION ON ACTUATOR PISTON THREADS OR ROD END THREADS.
3. COAT ACTUATOR THREADS AND THREAD RELIEF AS WELL AS ROD END THREADS, WITH CIC MASTINOX 6856K OR CORBAN 27L, AND RE-INSTALL ROD END ONTO ACTUATOR ASSEMBLY.
4. ADJUST ACTUATOR RETRACTED LENGTH USING TOOL CG 56806 REQUIREMENTS OR IN ACCORDANCE WITH CMM 32-31-06 REQUIREMENTS. OPTIONAL PROCEDURE PER STEP 13, ABOVE, IS ALSO ACCEPTABLE
5. TORQUE JAM NUT TO 660-980 IN-LBS AND SAFETY LOCKWIRE PER MS 33540.

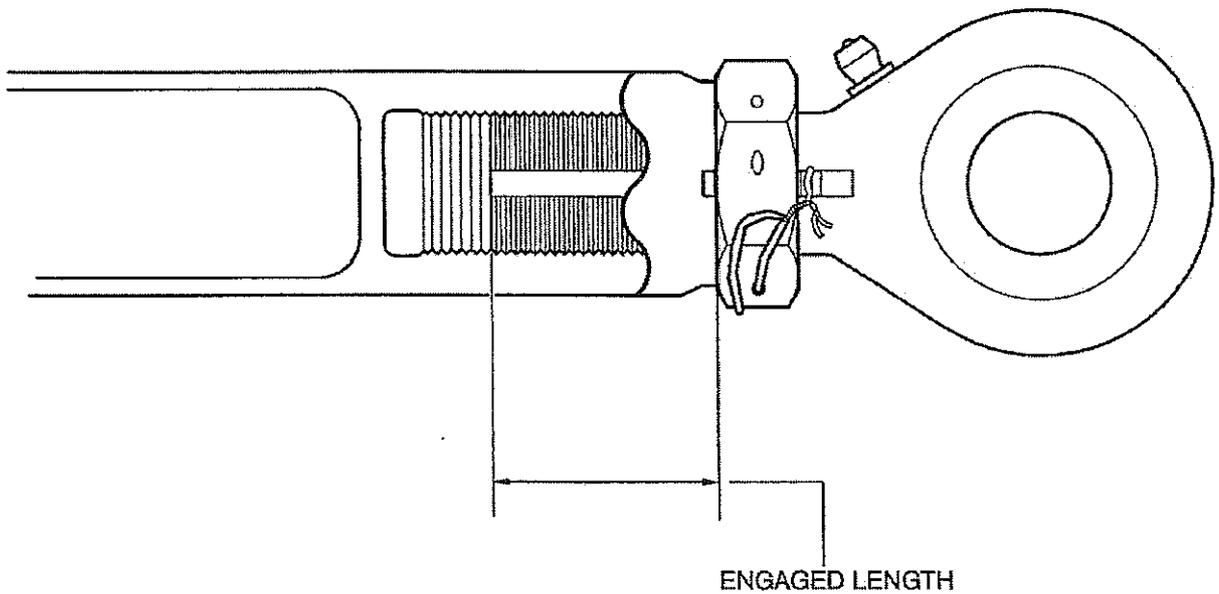
FIGURE 2

4. **ACCEPTANCE CRITERIA**
 - A) LIGHT SURFACE CORROSION (NO PITTING) OVER THE ENTIRE THREADED LENGTH WITH AT LEAST FIVE CONSECUTIVE FULL UNDAMAGED THREADS WITHIN THE ENGAGED THREAD LENGTH (REF FIGURE 2) IS ACCEPTABLE FOR **1000 FC OR 6 MONTHS** (WHICH EVER OCCURS FIRST) OF CONTINUED SERVICE. RETRACT ACTUATOR TO BE INSPECTED TO ENSURE JAM NUT IS SECURE AND WIRE LOCK IS IN PLACE EVERY **100 FC**.

- B) EVIDENCE OF MODERATE TO SEVERE PITTING CORROSION BEYOND CRITERIA STATED IN A). MUST BE REPAIRED PER SALVAGE DRAWING S2116 OR REPLACED.

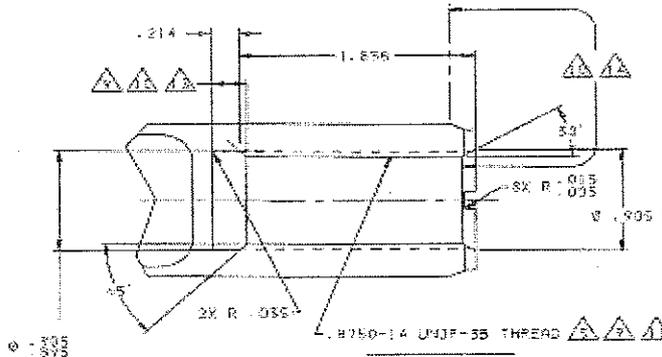
FIGURE 1

10. VISUALLY INSPECT PISTON (P/N 46570-1/-3) THREADS AND THREAD RELIEF AREA FOR EVIDENCE OF CORROSION AND/OR DAMAGE AND/OR PITTING (REF. FIGURE 1), USING A SMALL MIRROR UNDER ADEQUATE LIGHTING CONDITIONS. INSPECT WITH 10 X MAGNIFICATION MIRROR UNDER ADEQUATE LIGHTING CONDITIONS WITHIN **500 FC**

- IF CORROSION IS FOUND IN THREADED AREA OF PISTON P/N 46570-1/-3 PERFORM REWORK IN ACCORDANCE WITH **SECTION B** OF THIS SCR
 - IF NO CORROSION IS FOUND CONTINUE WITH REMAINING OPERATIONS

1. DISASSEMBLE AS REQUIRED TO REMOVE ROD END P/N P3A2750 FROM ACTUATOR ASSEMBLY.
2. INSPECT - ENSURE NO EVIDENCE OF CORROSION ON ACTUATOR PISTON THREADS OR ROD END THREADS.
3. COAT ACTUATOR THREADS AND THREAD RELIEF AS WELL AS ROD END THREADS, WITH CIC MASTINOX 6856K OR CORBAN 27L, AND RE-INSTALL ROD END ONTO ACTUATOR ASSEMBLY.
4. ADJUST ACTUATOR RETRACTED LENGTH USING TOOL CG 56806 REQUIREMENTS OR IN ACCORDANCE WITH CMM 32-31-06 REQUIREMENTS. OPTIONAL PROCEDURE PER STEP 13, ABOVE, IS ALSO ACCEPTABLE
5. TORQUE JAM NUT TO 660-980 IN-LBS AND SAFETY LOCKWIRE PER MS 33540.

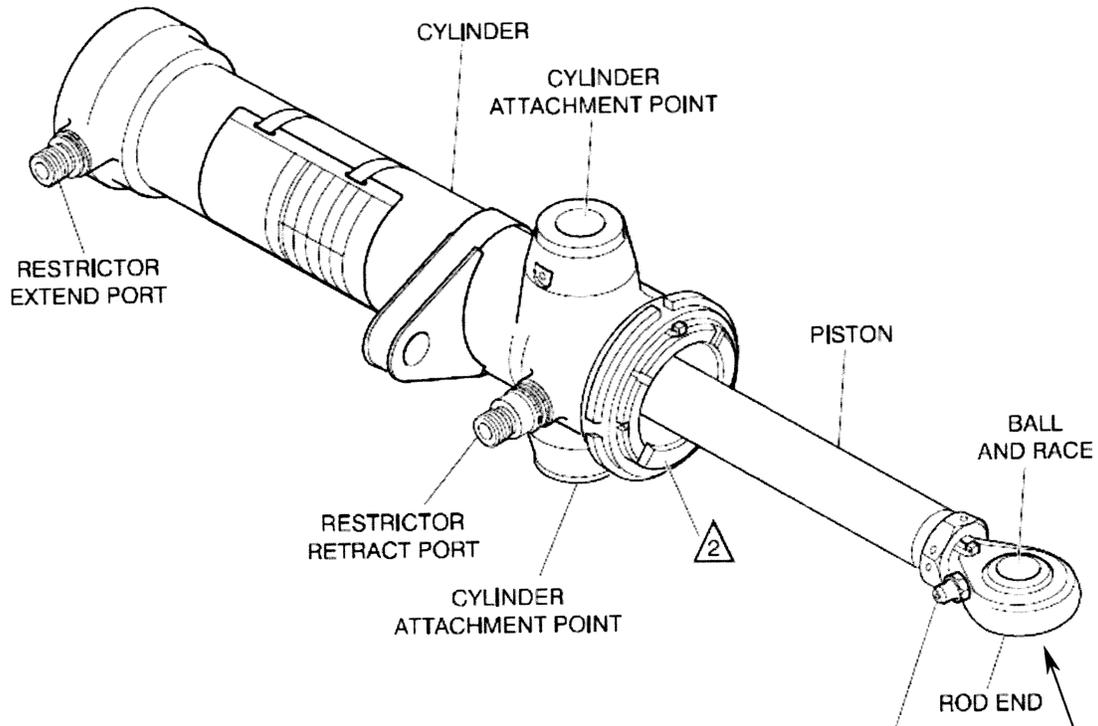
Retraction actuator assembly p/n 46550-7/-9

Inspect affected parts for any signs of corrosion or wear.

Remove the rod end of the retraction actuator assembly in accordance with SCR 086-07 rev. D

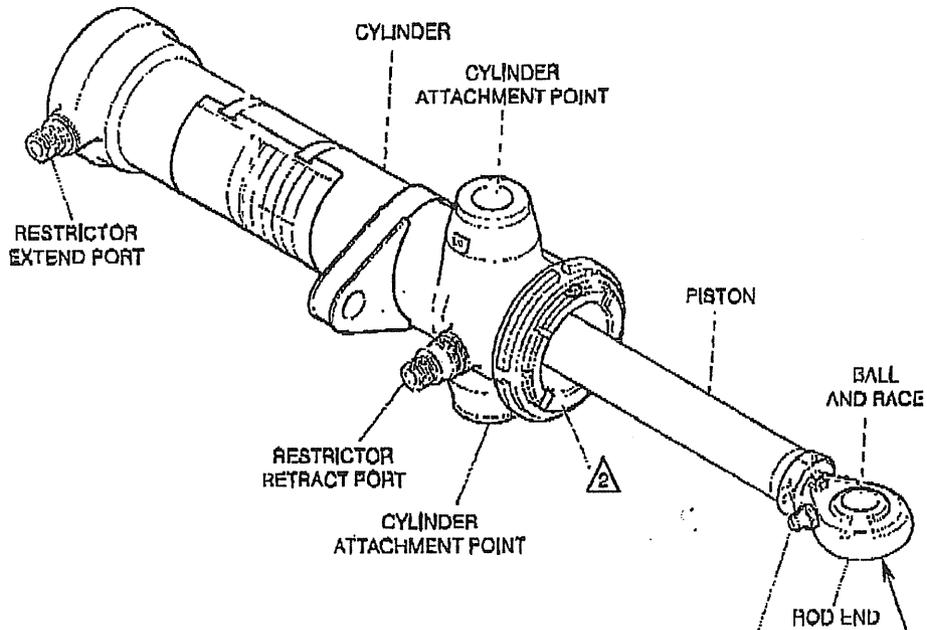
Retraction actuator assembly p/n 46550-77-9

Inspect affected parts for any signs of corrosion or wear.

Remove the rod end of the retraction actuator assembly in accordance with SCR 086-07 rev. ~~A B~~ **C**

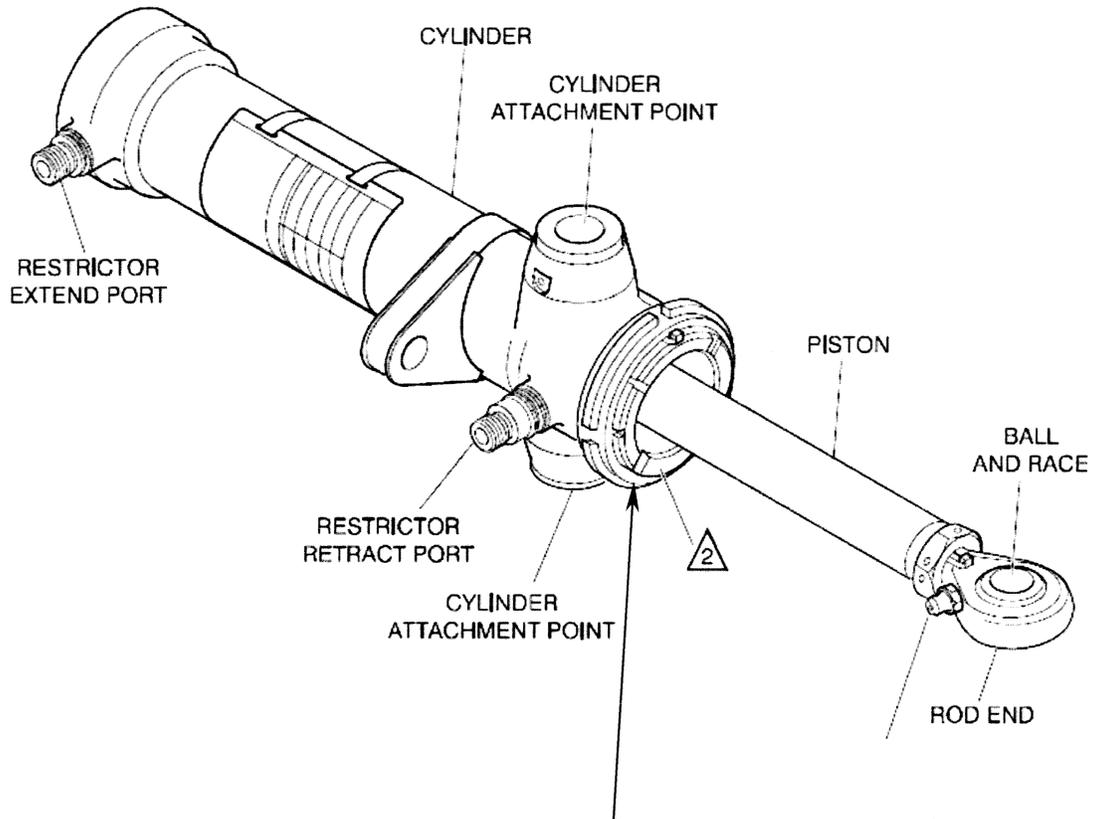
Retraction actuator assembly p/n 46550-7/-9

Inspect cylinder P/N 4655-1 for evidence of corrosion on Gland Nut threads.

Remove the rod end of the retraction actuator assembly in accordance with SCR 091-07 rev. NC
